# **Port Authority Facility Condition Survey Program**

**Port Authority Bus Terminal  
2014 Inspection Report of  
Bus and Car Parking Level Slabs**

**November 2014**

Subject: CONDITION SURVEY OF PORT AUTHORITY BUS TERMINAL, BUS AND CAR PARKING LEVEL SLABS P.O. 4900010549

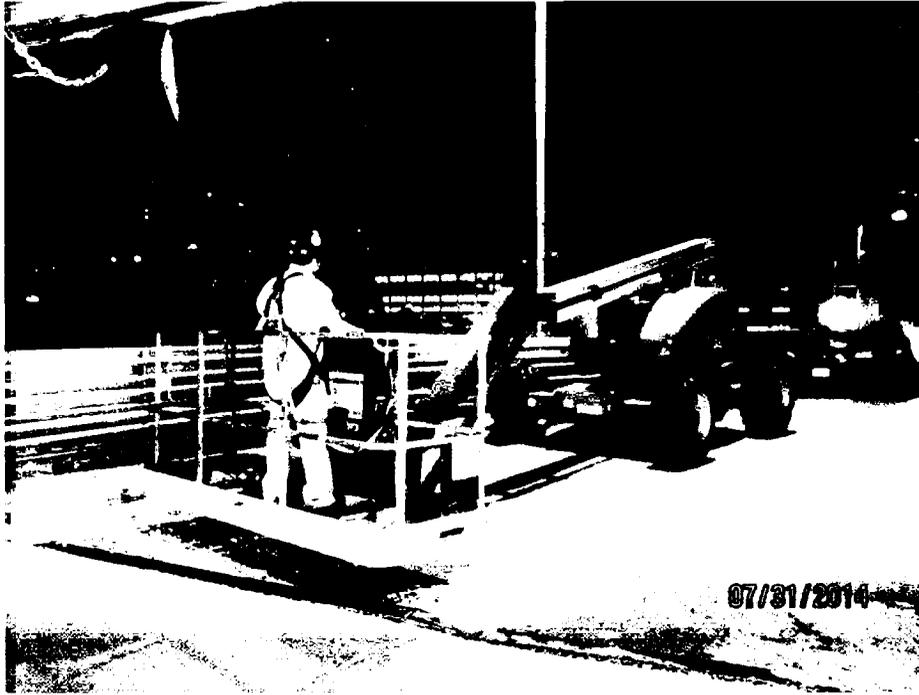
**Photo No. A2**

**Location:**  
Upper Bus Level,  
South Wing,  
Entrance Ramp to  
Upper Bus Level  
(looking southwest,  
shown on Dwg. 16,  
pg. 45)

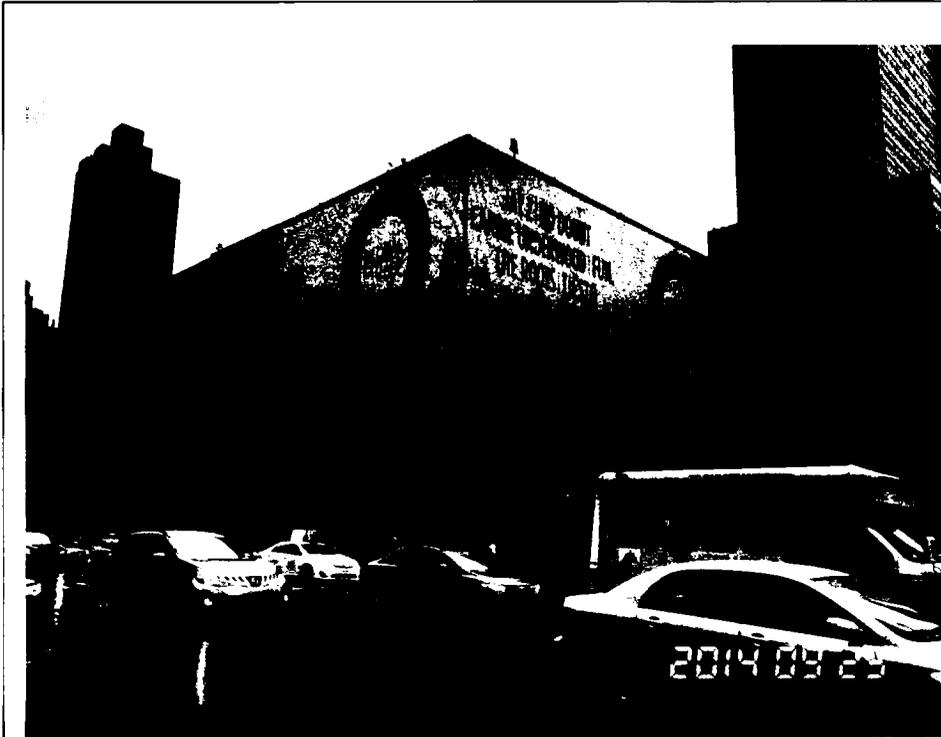
**Photo No. 1**

**Location:**  
North and East  
Elevation (looking  
Southwest, shown  
on Location Plan,  
pg. xi)

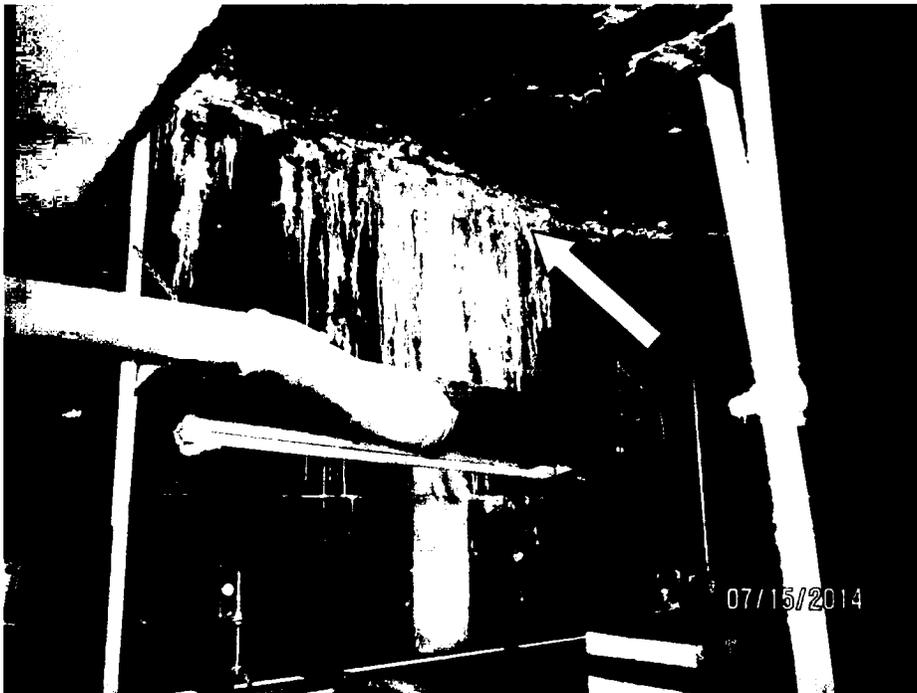
**Photo No. 8**

**Location:**  
Underside of  
Suburban Bus  
Level, South Wing  
Column Lines  
J-K/24 (looking  
west)

**Description:**  
Underside of  
deteriorated  
expansion joint with  
water leakage  
resulting in water  
infiltration of the  
concrete  
encasement and  
corrosion of the  
primary member

**PRIORITY  
REPAIR 1**

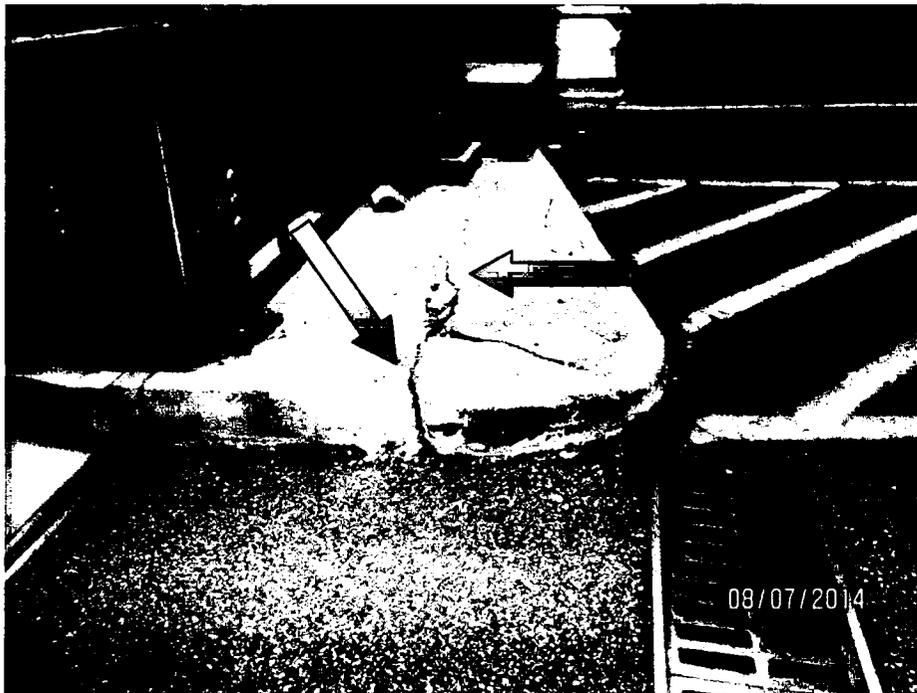
**Photo No. 12**

**Location:**  
Car Parking Level  
7, South Wing  
Along Column Line  
3, between Column  
Lines U0-U1  
(looking north)

**Description:**  
Wide cracks in  
concrete curb and  
safety walk with  
spalls and hollow  
sounding areas of  
concrete adjoining  
the cracks.

**SAFETY  
REPAIR 3**

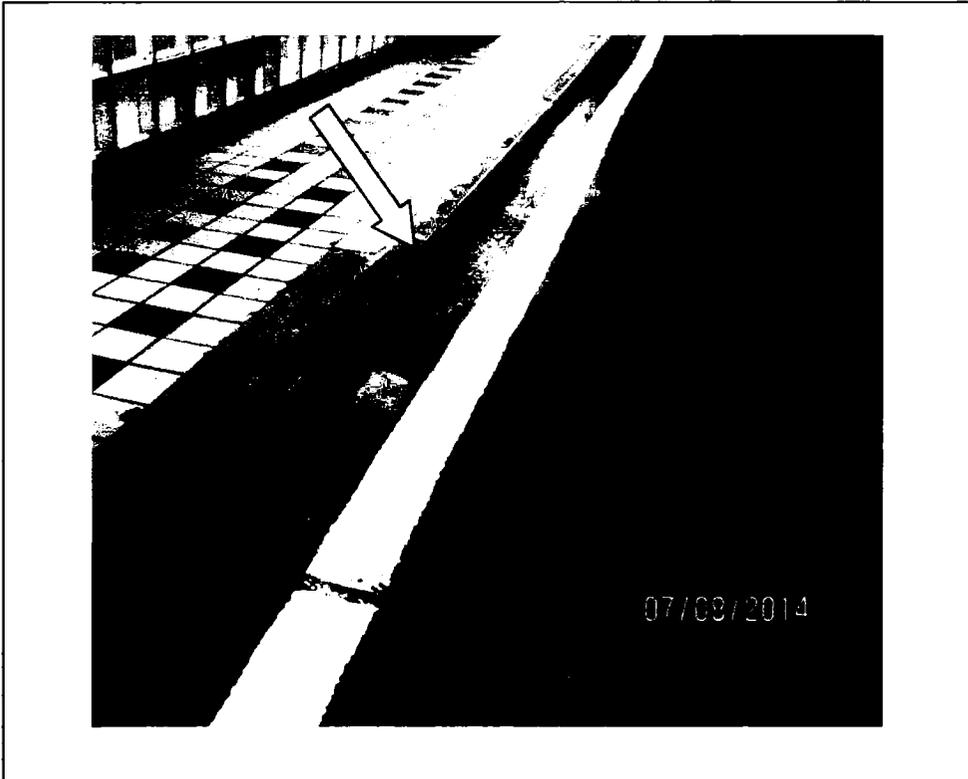
**Photo No. 13**

**Location:**  
Suburban Bus Level, South Wing  
Between Column Lines K-L and  
Column Lines 23-24 (looking west)

**Description:**  
Uneven tiles adjacent to the curb with vertical offset of ~ 1/2" between the curb plate and the tiles.

**SAFETY REPAIR 4**

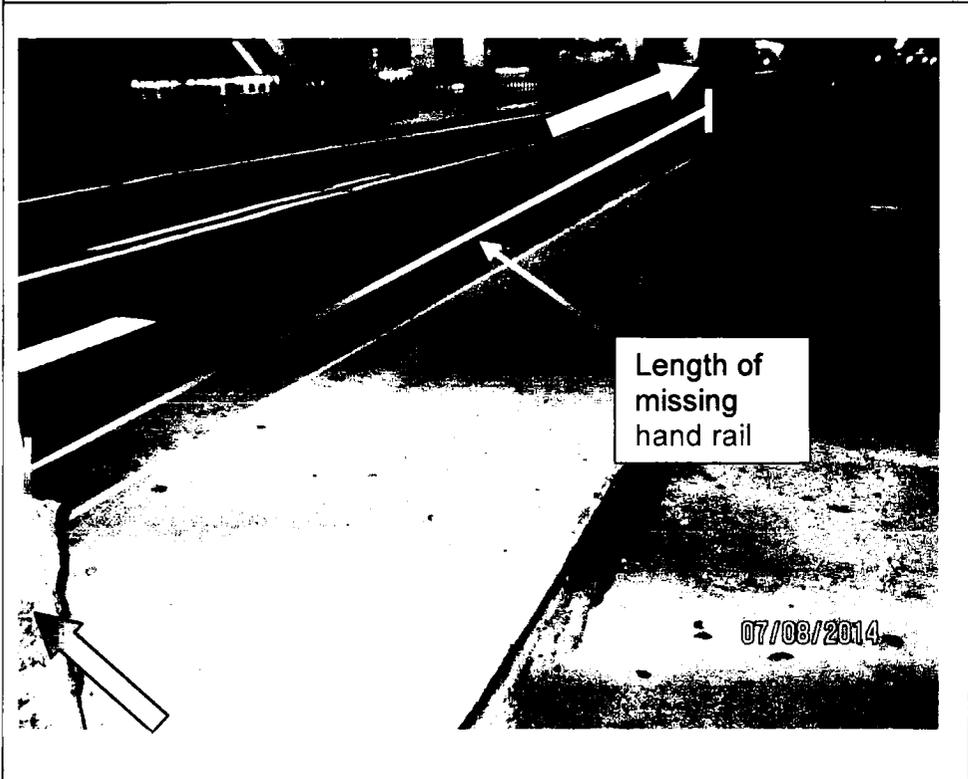
**Photo No. 14**

**Location:**  
Suburban Bus Level, South Wing  
Between Column Lines 24-26, along  
Column Line K (looking southwest)

**Description:**  
Hand railing is missing between columns.

**SAFETY REPAIR 5**

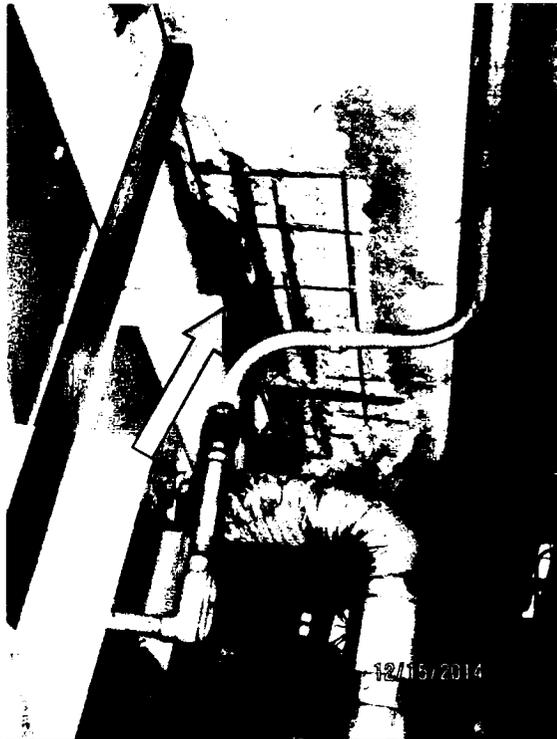
<p><b>Photo No. 21</b></p> <p><b>Location:</b> West Truss, Bottom of Bottom Chord, Column Lines 1/L1-L2 (looking north)</p> <p><b>Description:</b> Concrete encasement spalled off the bottom of the bottom chord exposing rebar and post-tensioning strands. Two of the four strands are severely corroded.</p> <p><b>PRIORITY REPAIR 2</b></p>

PABT-BDOSW-009	<u>West Truss</u> Bottom Chord - Column Line 1 between Column Lines L1 & L2	Concrete encasement spalled off in a 8' x 26" area along the bottom of the bottom chord resulting in exposed rebar and post-tensioning strands. Two of the four strands are severely corroded.	New	Repair the bottom chord.	Photo 21 & 22/Dwg 25

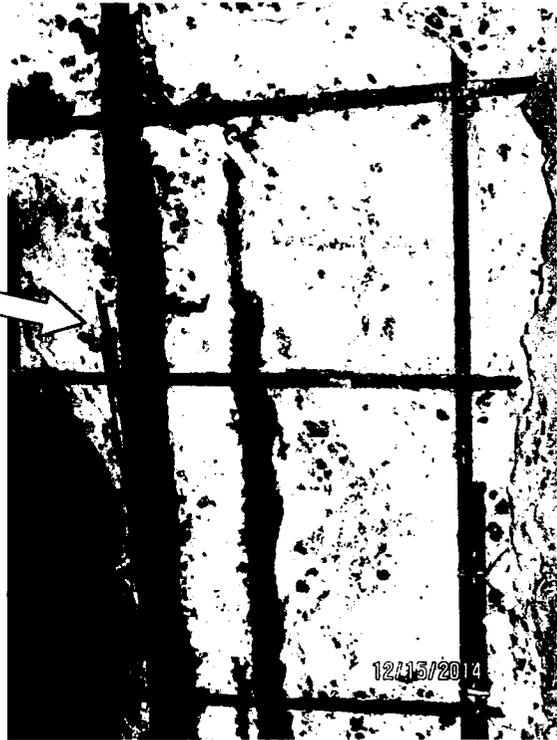
<p><b>Photo No. 22</b></p> <p><b>Location:</b> West Truss, Bottom of Bottom Chord, Column Lines 1/L1-L2 (looking up and north)</p> <p><b>Description:</b> Severely corroded post-tensioning strands with several broken wire (close up of Photo 21 above)</p> <p><b>PRIORITY REPAIR 2</b></p>

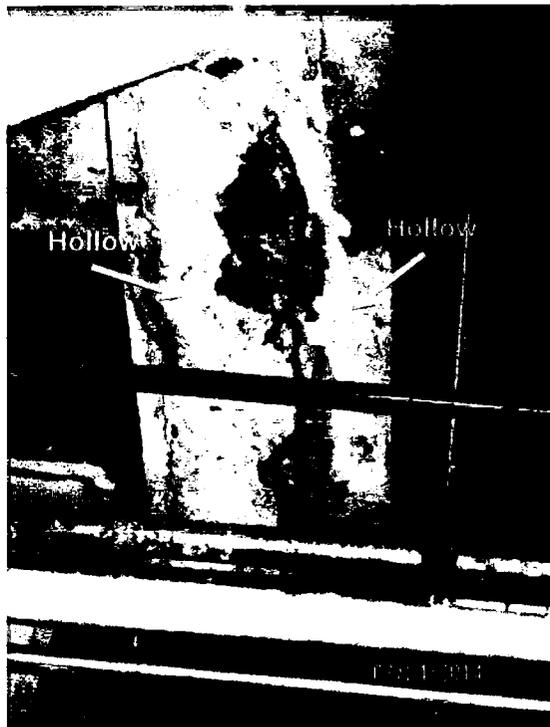
**Photo 4:** Underside of the Parking Level 6 (truss line 27 at panel point U0, looking south) – Delaminated and Hollow area (2 SF) around the spall.
