**Engineering
Quality Assurance Division
B02-925.078**

Port Authority Facility Condition Survey Program

September 2011

Reference: P. A. Agreement No. 405-11-022
Professional Services for the Condition Survey of
Holland Tunnel Air Ducts and Drum Rings

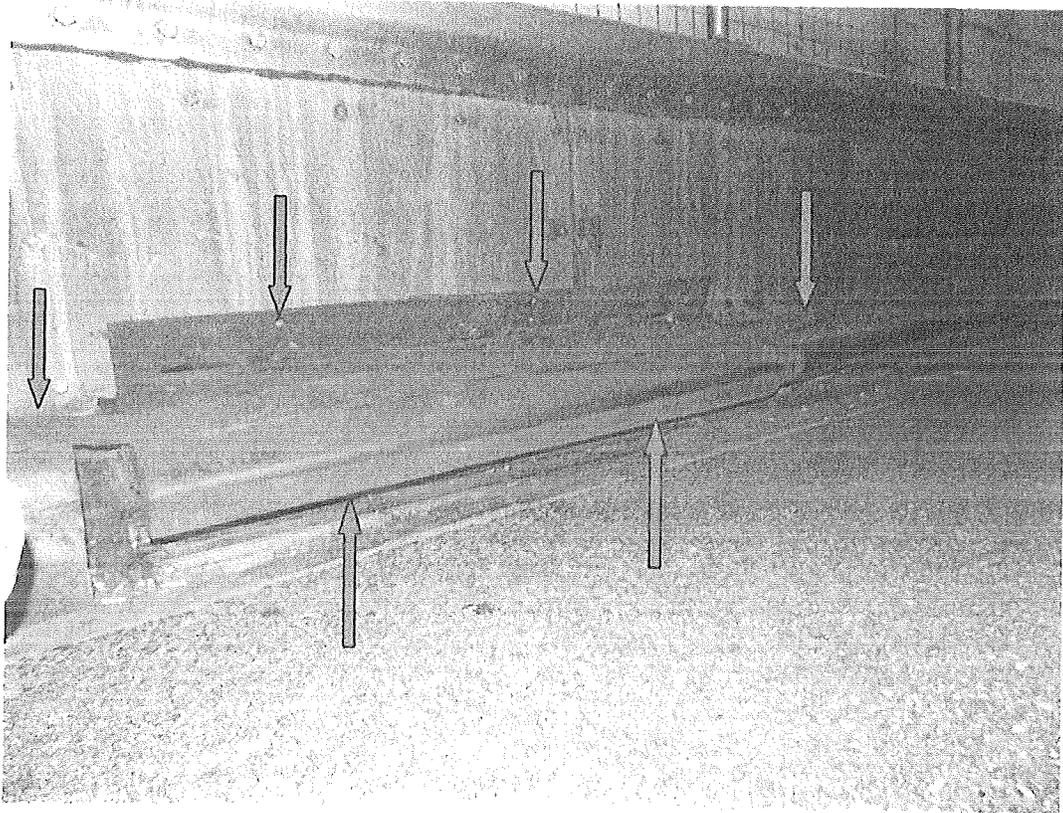
Photo 1 South Tunnel – Roadway – Station 83+50 to 83+55 – Approximately 5 ft. long section of unsecured curb resting on adjacent curbing.

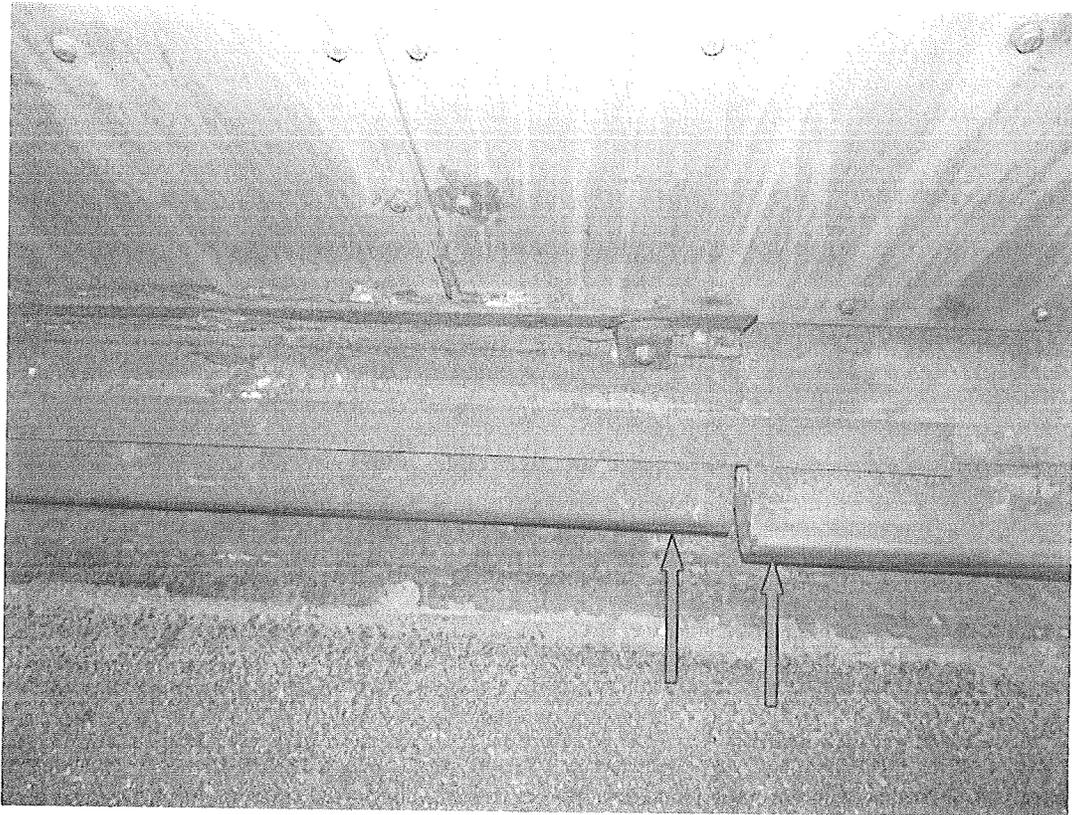
Photo 2 South Tunnel – Roadway – Station 83+55 – Approximate 1 ½" offset between unsecured curb section and adjacent curb.
