List of specific record(s):
I am requesting copies of any and all reports prepared by Haag Engineering of Sugar Land TX, the expert retained to investigate the February 16, 2012 Crane Incident at World Trade Center

World Trade Center 4500063211
4 World Trade Center
New York, NY
Client File: 4500063211
Haag File: 0212001176-250

The Port Authority of NY and NJ
Port Authority Safety Board
225 Park Avenue South 15th Floor
New York, NY 10003

December 21, 2012

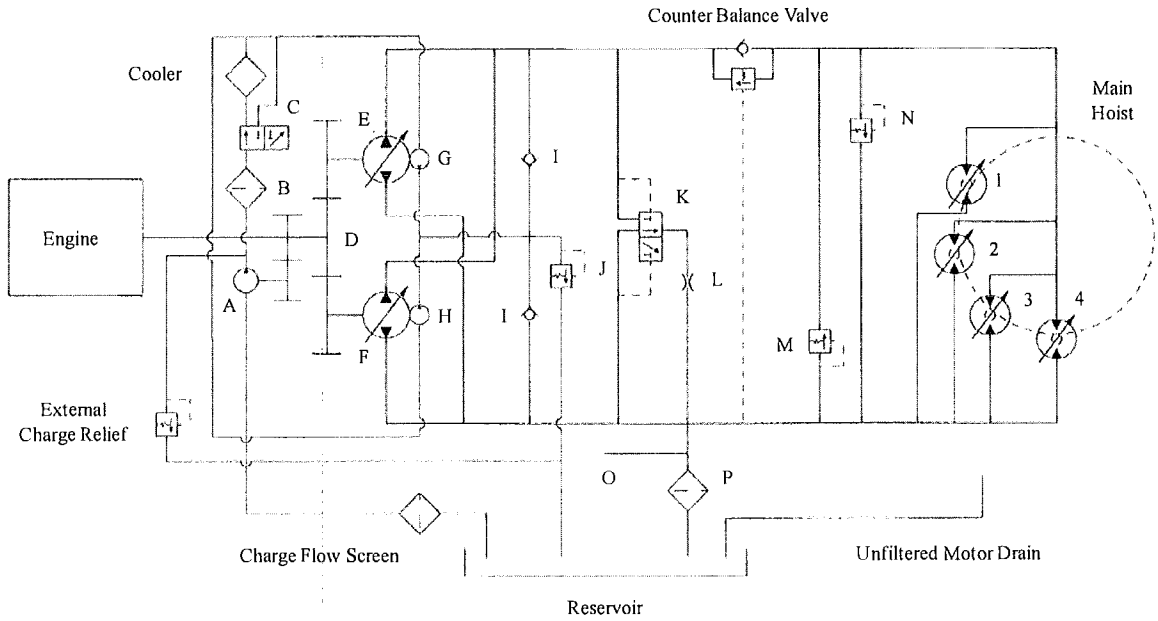
Figure 2. A schematic of the hydraulic circuit for the main hoist system

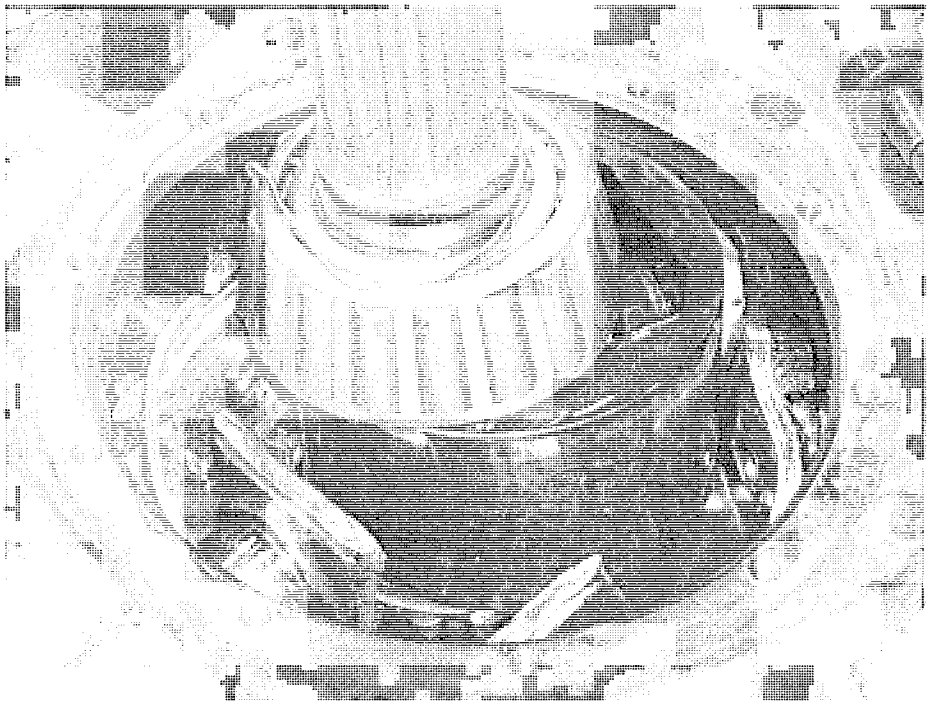
1. The hydraulic motor labeled 4 in Figures 1 and 2 was disassembled first. There was an obvious interest in disassembling this motor first because the case had a large hole in it, from which a connecting rod had been thrown out of the machine during failure, along with another large piece of metal that appeared to belong to one of the hydrostatic bearings. Figure 3 shows the type of failure that was observed for Motor 4 (and the other 3 motors). The following things were observed during the disassembly process:

Figure 3. The typical finding of a motor failure in which metal parts were scattered randomly, conrod shoes were highly deformed, and motor pistons were either jammed or partially jammed within their bores.

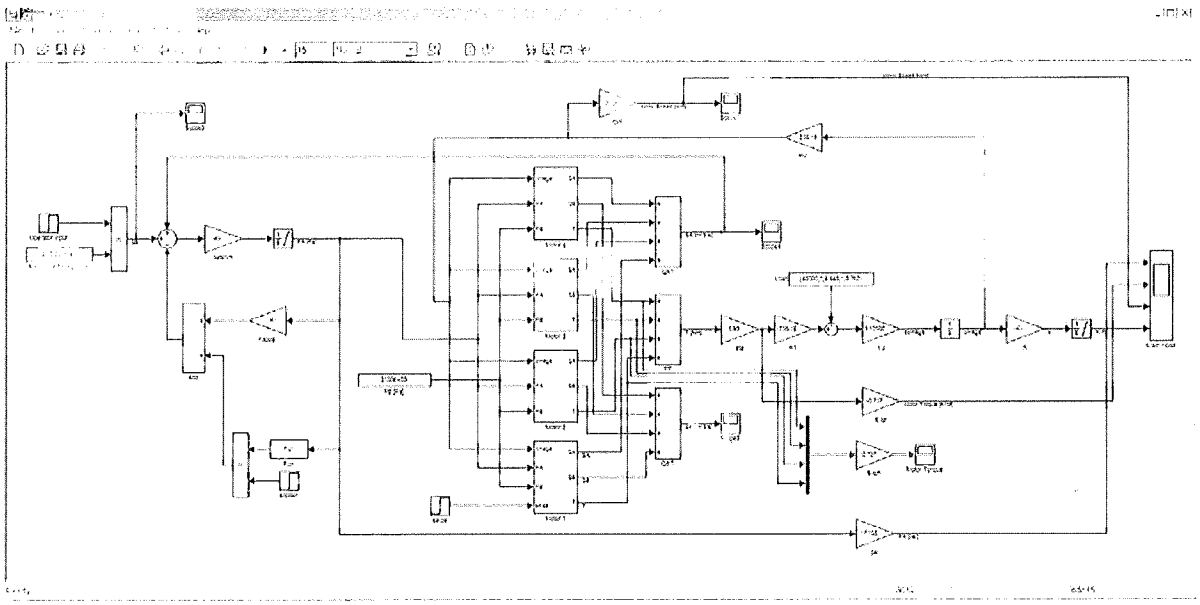
Figure 4. The graphical user interface for the numerical model that was developed in Matlab/Simulink® for simulating the condition of a seized distributor in one of the motors

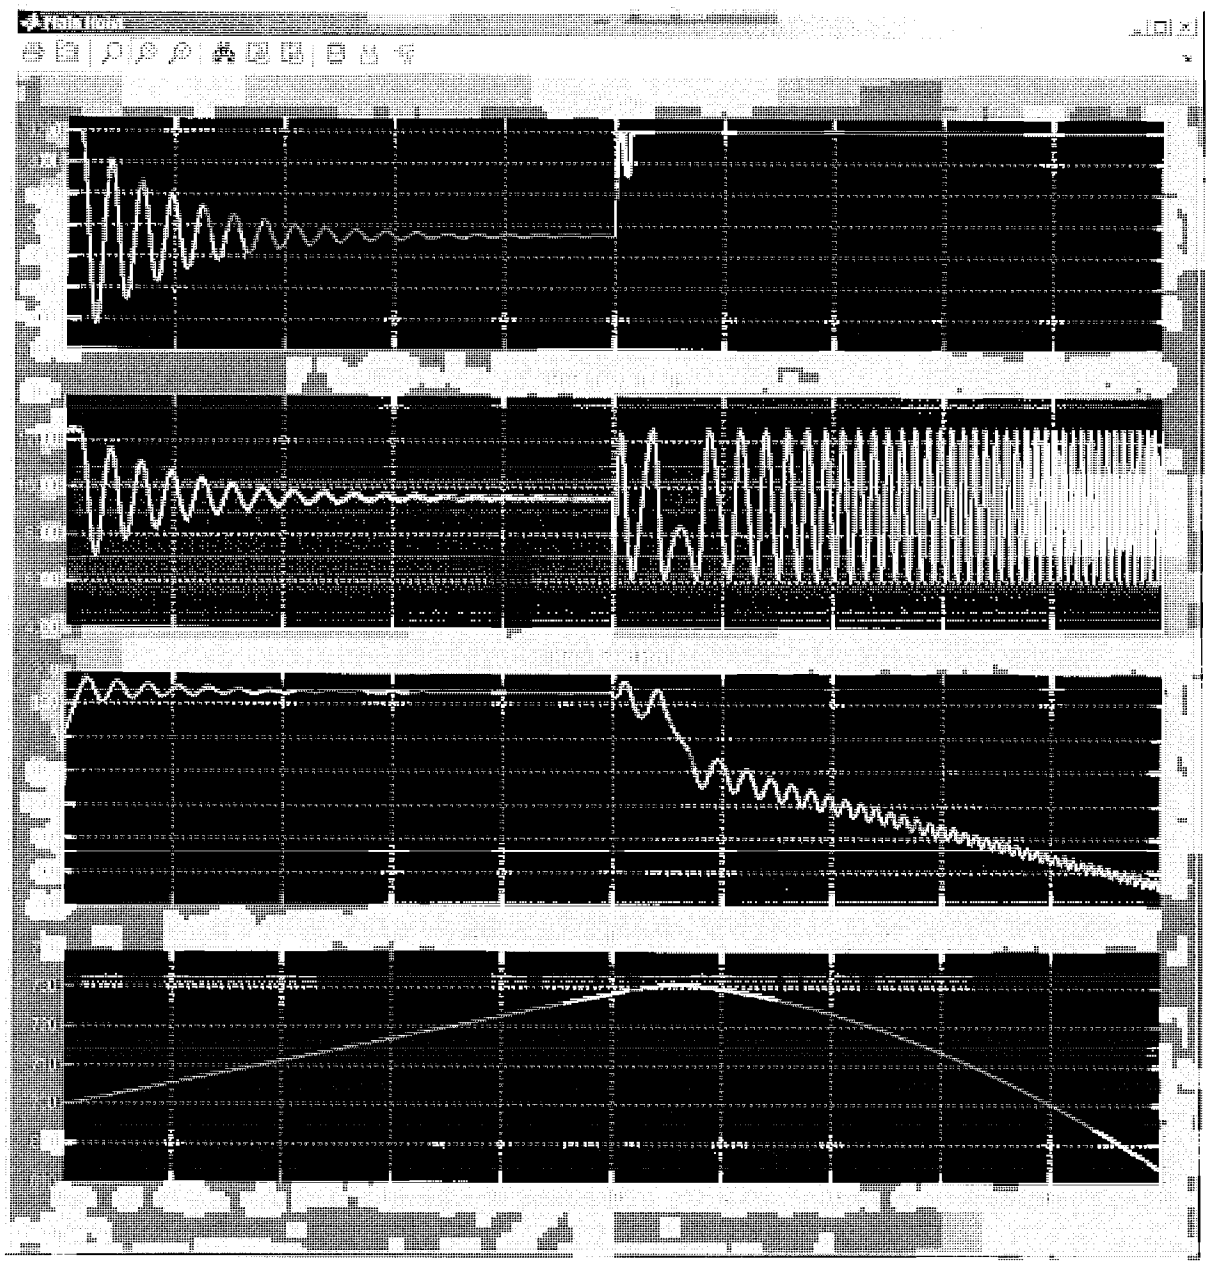
Figure 5. Simulation results for the lost-load incident of the Linkbelt 1900 crane, on February 16, 2012.

oscillatory effects of this torque on the total system are also shown in the second strip chart of Figure 5. In the end, this appears to be the most plausible explanation for the lost-load incident of February 16, 2012.

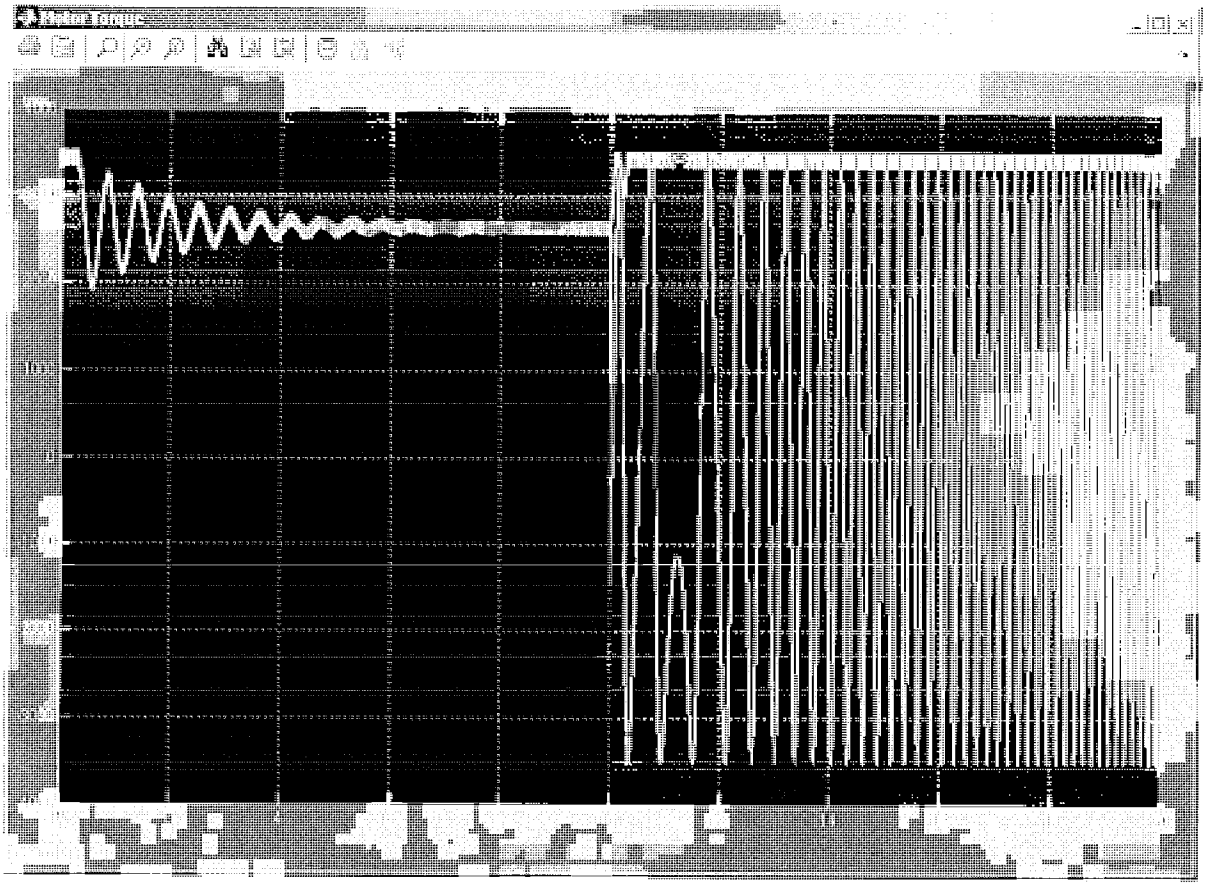
Figure 6. Instantaneous torque of all four motors being used to lift the load on the Linkbelt 1900 crane. The torque from the motor with a seized distributer is shown in red, and the average value of this torque is shown to oscillate about zero.

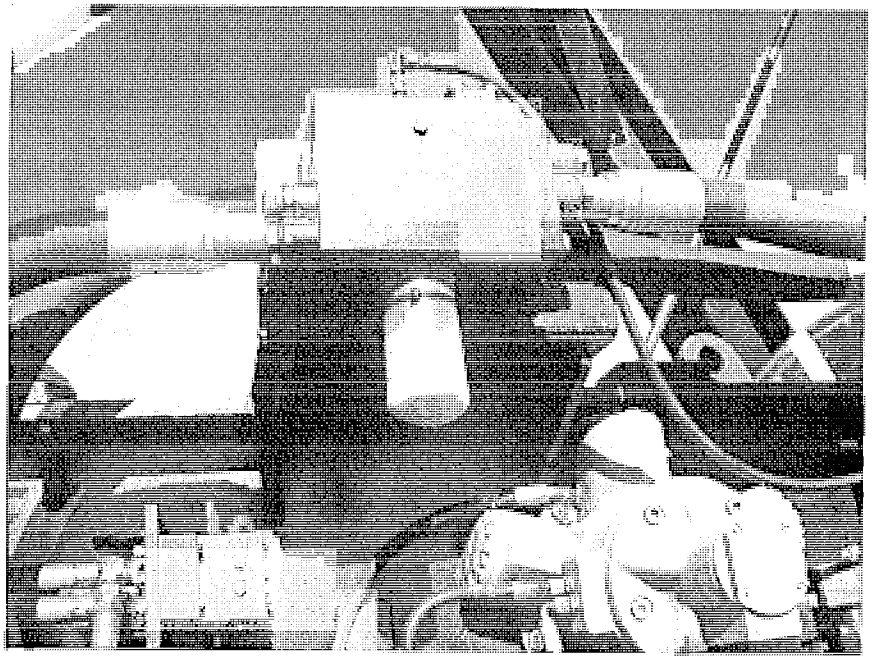
Figure 4
Load Holding Valve
(plastic cup in place)

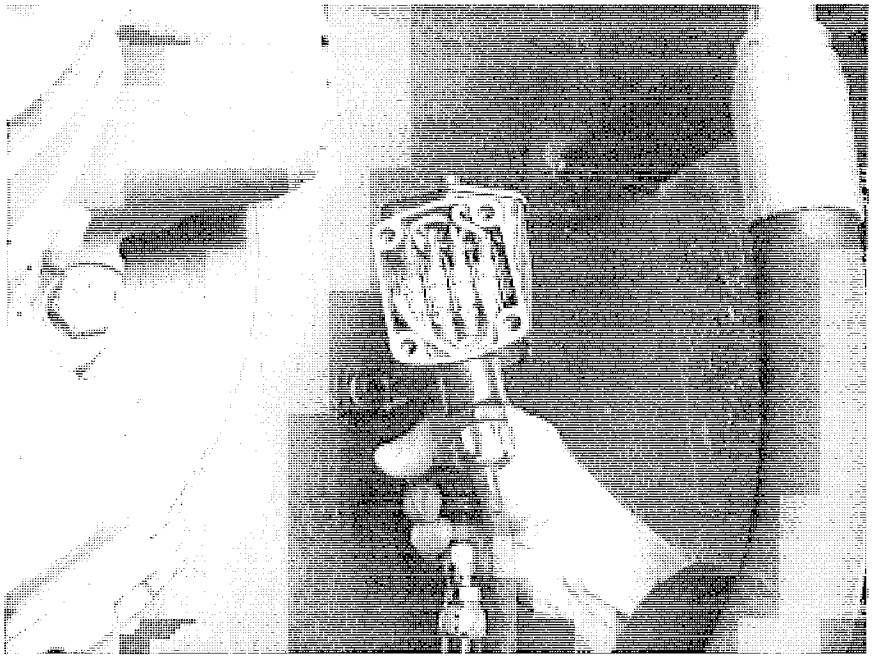
Figure 6
Barksdale Switch
Bypass Jumper Wire (green)

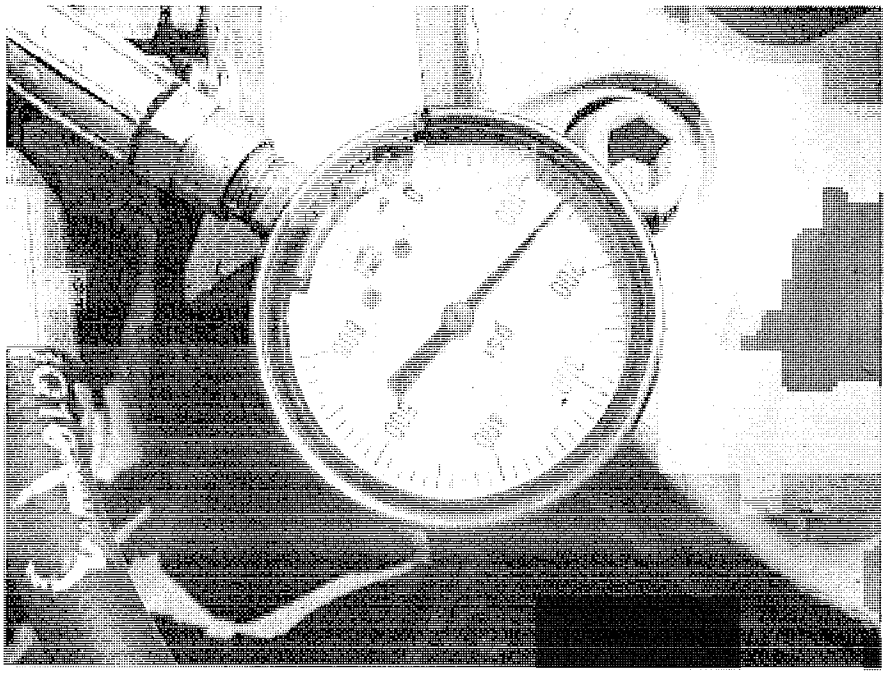
Shuttle Relief Valves set below the design value are likely to cause partial cavitation during sustained operation at higher motor speeds, with lower hook loads, contributing to overheating and the observed cumulative wear of the hydraulic motor distributors, which in turn has lead to the observed failure of one motor and near failure of the remaining two.

Figure 7
Shuttle Relief Valve Pressure

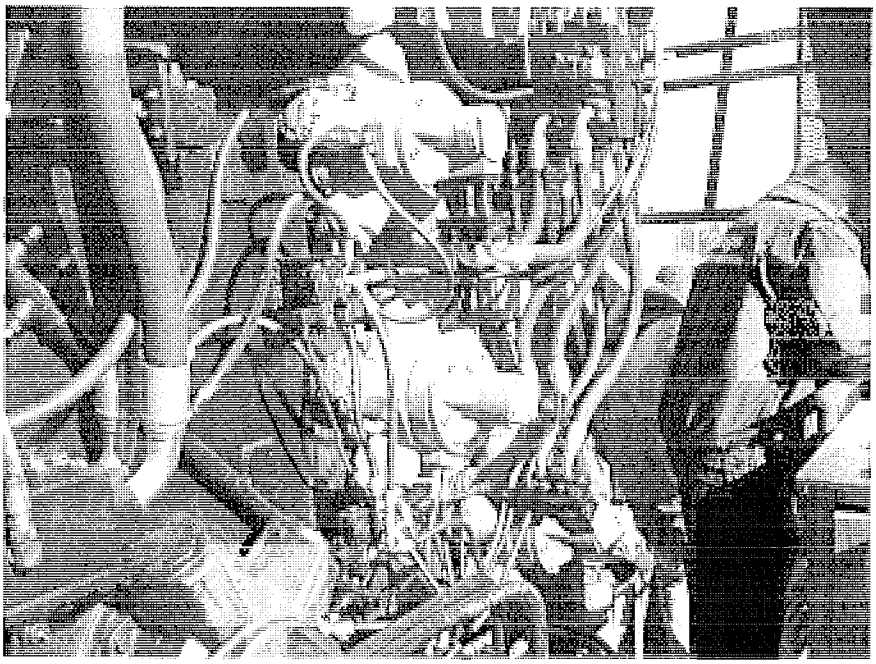
Figure 8
Staffa Radial Motors (3)
Boom Motor (1) at Bottom-left

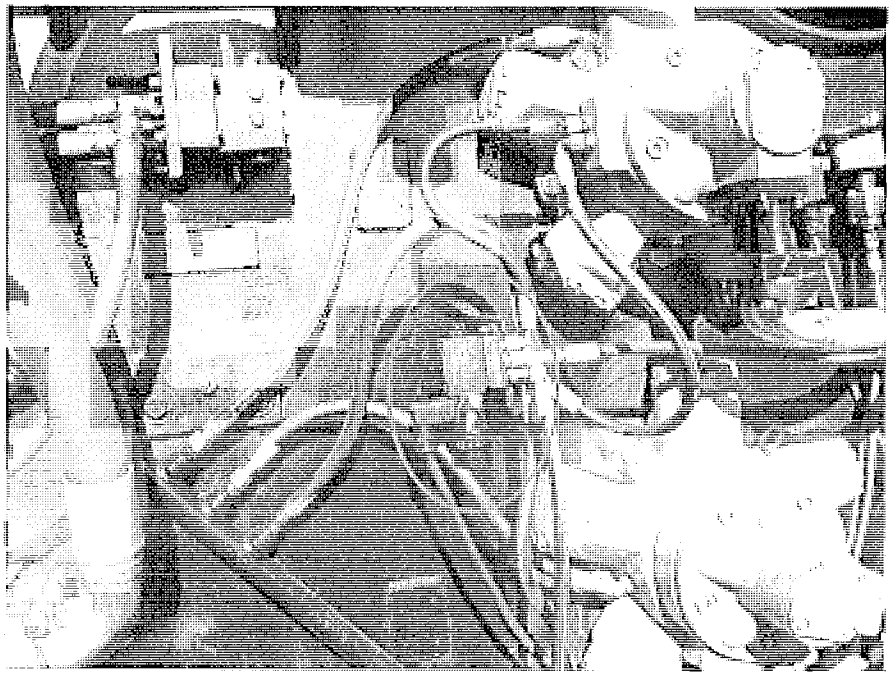
Figure 9
High Shift Valve
(typical)

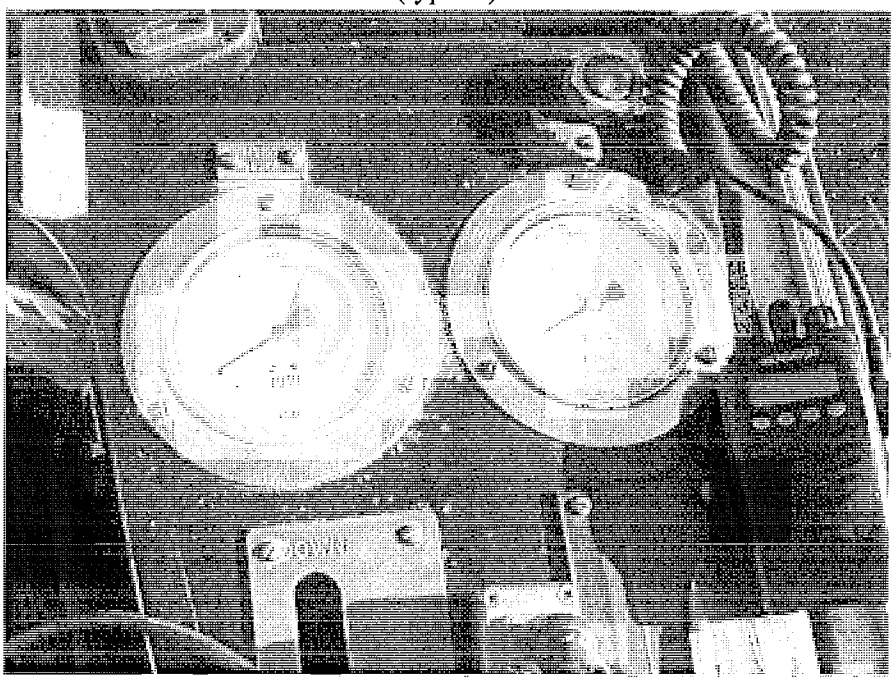
Figure 10
Low Charge Pressure Light
(apparently unmarked)

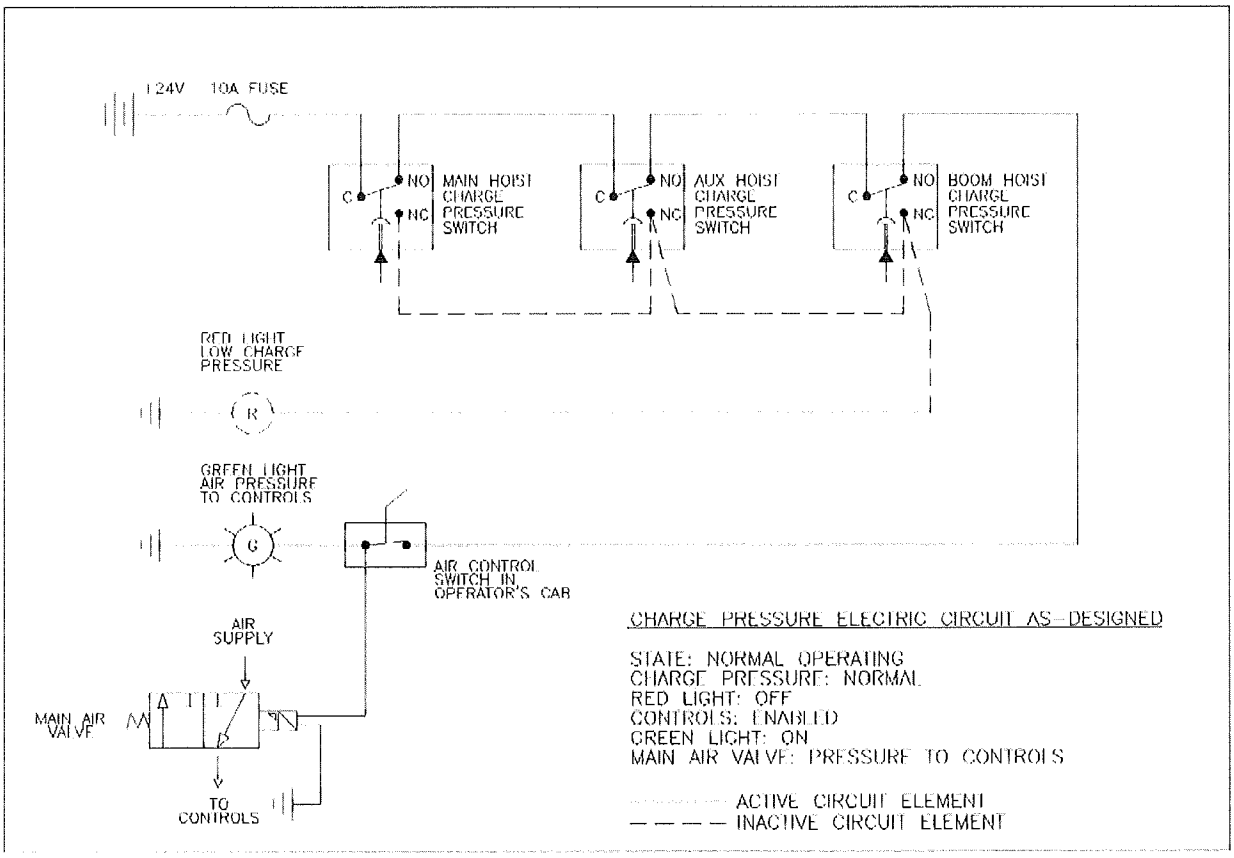
Figure 11
Charge Pressure Protection Circuit
As-designed
Normal Operation

With adequate charge pressure at each of the three Charge Pressure Switches, current passes from the source to the Air Control Switch on the operator's console, and on to the Main Air Valve, lighting the green light on the console. The operator's controls are enabled.

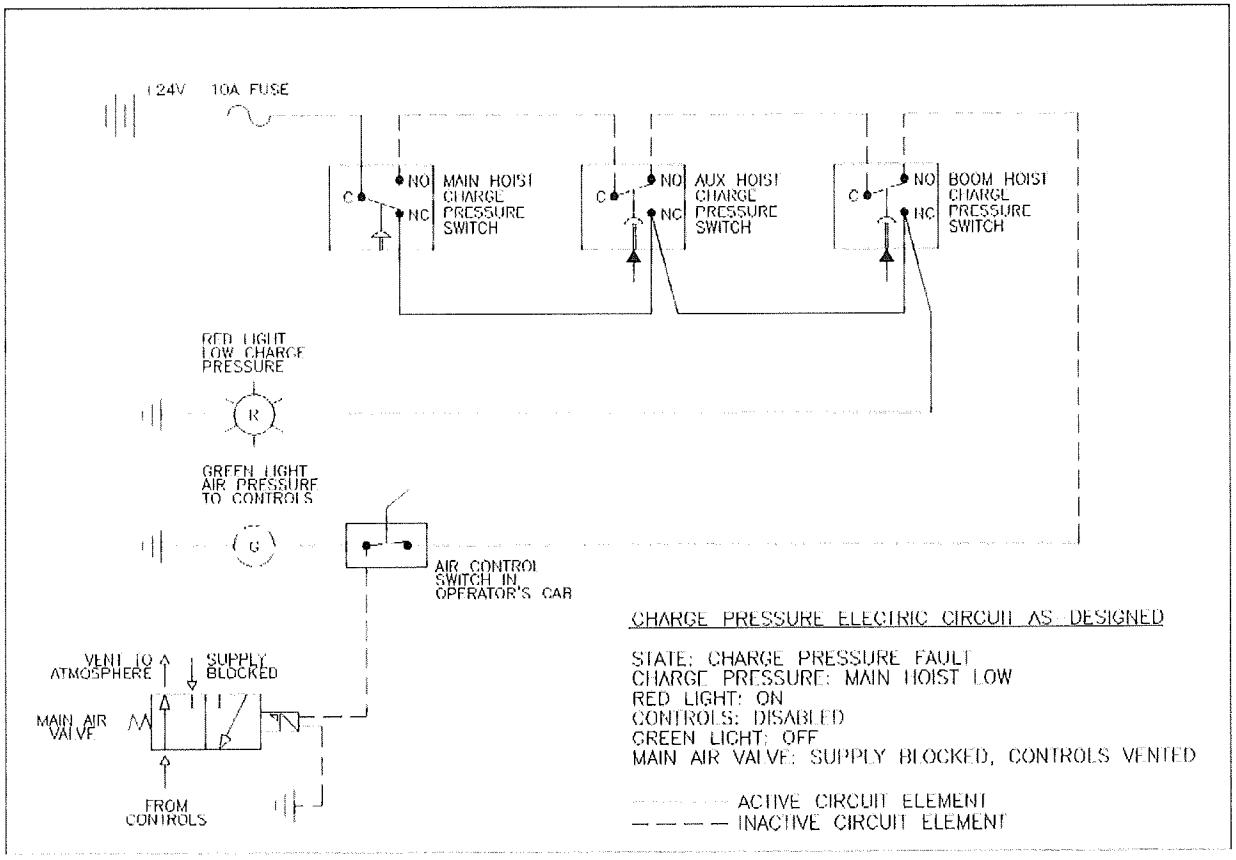
Figure 12
Charge Pressure Protection Circuit
As-designed
Low Charge Pressure

With low charge pressure at the main hoist Charge Pressure Switch, current passes from the source to the red light on the operator's console, and the circuit to the Main Air Valve and green light on the console is broken. Air within the operator's controls is vented to atmosphere, disabling the controls and setting the brakes.

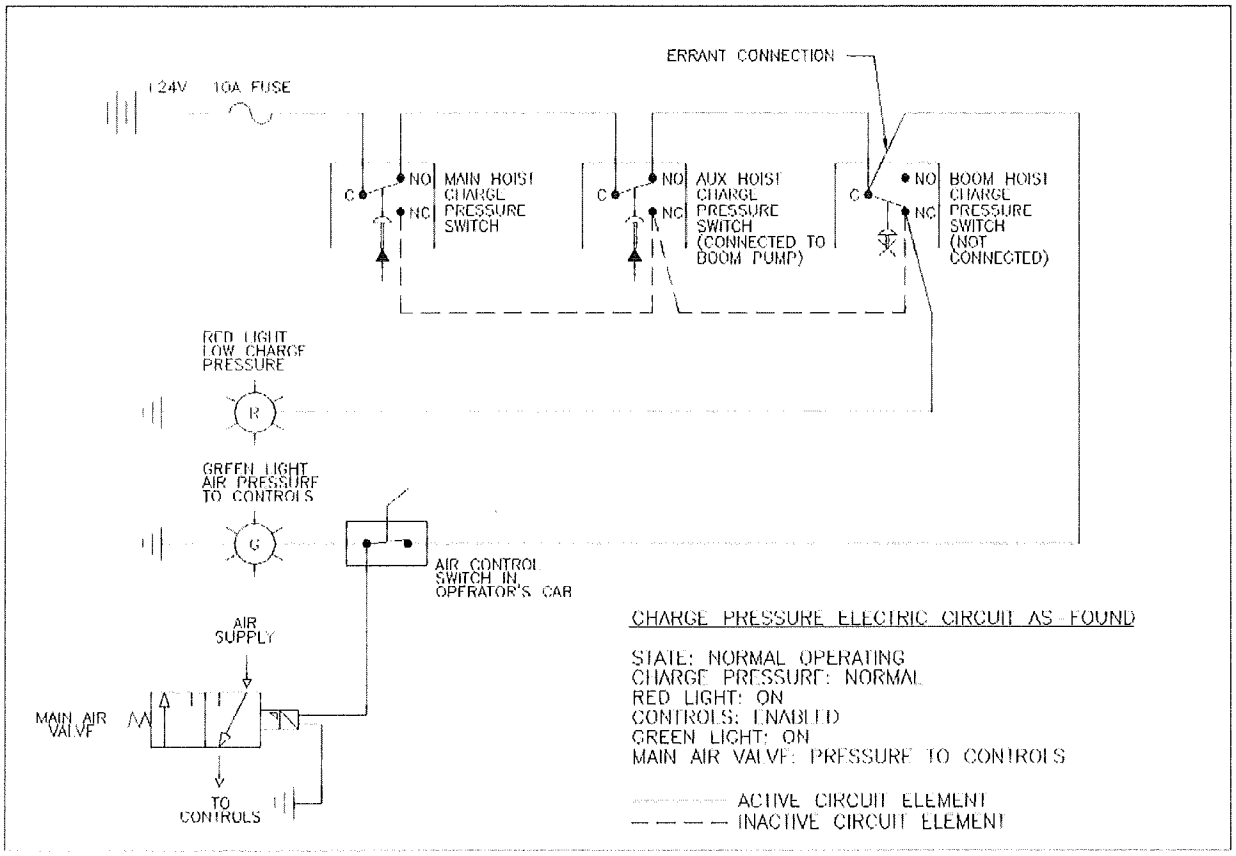
Figure 13
Charge Pressure Protection Circuit
As-Found
Normal Operation

With adequate charge pressure at each of the two working Charge Pressure Switches, and the original boom hoist Charge Pressure Switch hydraulically disconnected, current passes from the source to the Air Control Switch on the operator's console, and on to the Main Air Valve, lighting the green light on the console. The operator's controls are enabled. Current also passes through the boom hoist Charge Pressure Switch to the red Low Charge Pressure light on the operator's console.

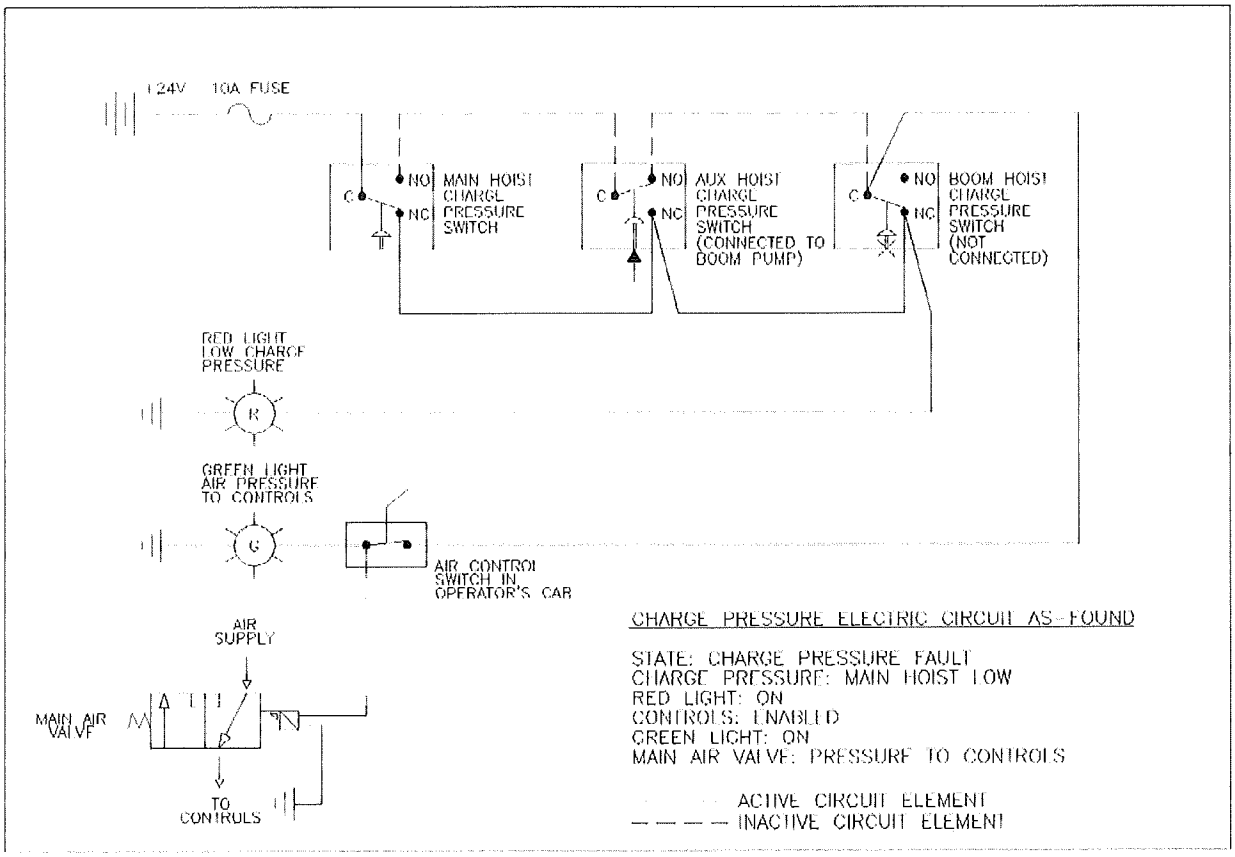
Figure 14
Charge Pressure Protection Circuit
As-Found
Low Charge Pressure

With low charge pressure at the main hoist Charge Pressure Switch, current passes from the source to the red light on the operator's console. Current is also back-fed through the boom hoist Charge Pressure Switch to the Air Control Switch on the operator's console and on to the Main Air Valve and green light on the operator's console. The operator's controls remain enabled, and the brakes remain under operator control rather than automatically setting.

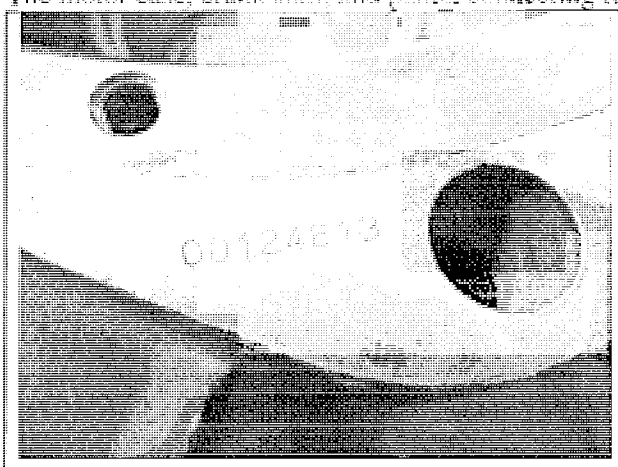
Serial number

Serial #00124813
This motor was identified as a new motor, meaning that it had operated for some time, but had never been previously repaired. It was also determined that this was the first motor to fail.
The Oldhams coupling in this motor was sheared and was able to spin upon the face of the crankshaft. The broken ends of the tang of the coupling remained inside the motor. The distributor valve housing was galled near the ports. The spool also had galling where it had contacted the valve housing. The o-rings in the C spacer housing were damaged. The inside surface of the connecting rod hold down rings had heavy contact with the connecting rod shoes.
The motor case, crankshaft, and piston connecting rod assemblies are all good condition.

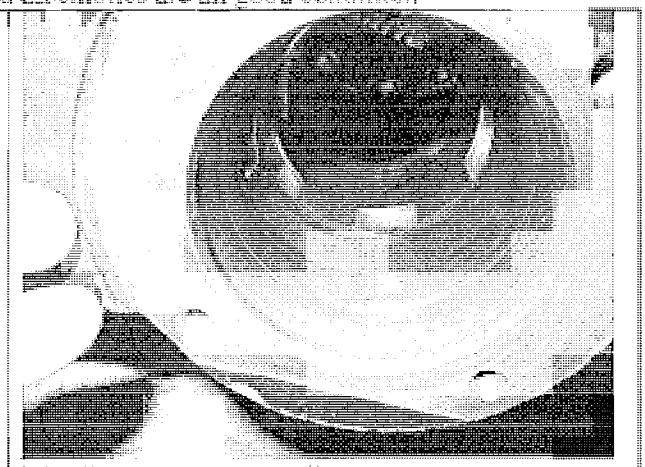
Distributor housing. Galling near ports.

The galling of the distributor is likely the result of a lack of lubrication, which is most often caused by cavitation or over speeding of the spool. Displacement of the o-rings is known to be caused by cavitation. If the motor is starved of oil and there is no oil flowing out, the motor can spin without control. Starved of lubrication, the spool will seize in the bore and lock. In this case, the drive coupling was damaged, but not completely broken.

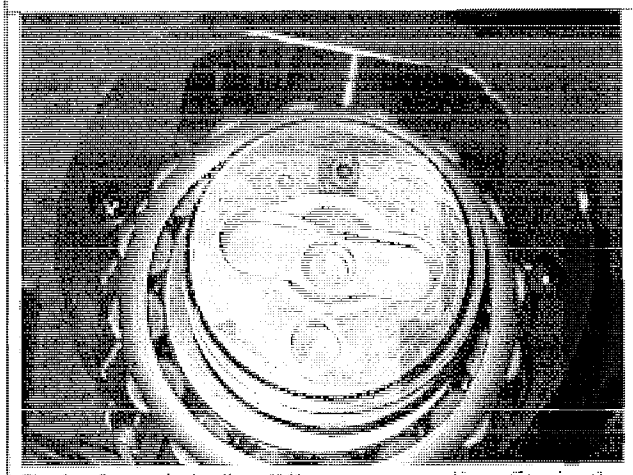
End of crankshaft. Olhamans coupling fits in the slot. The face is marked where the coupling contacted it while the crankshaft was turning.

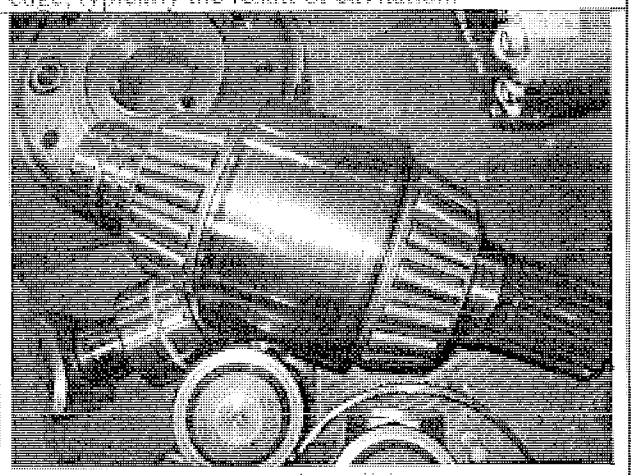
Crankshaft drum in good condition.

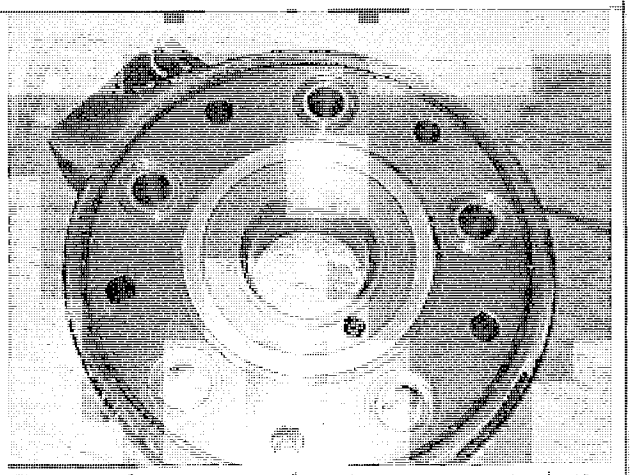
Copper has trepanned o-ring grooves to better retain the seals.

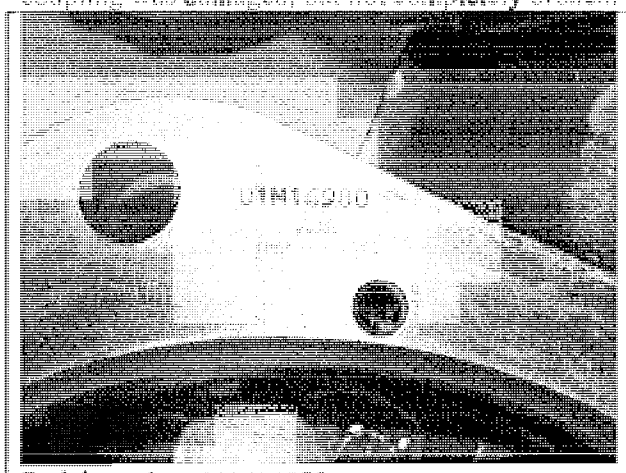
Serial number 01M16980

The galling of the distributor is likely the result of a lack of lubrication, which is often caused by cavitation or over speeding of the motor. If the motor is starved of oil and there is no oil flowing out, the motor can spin without control. Starved of lubrication, the spool will seize in the bore and lock. In this case, the drive coupling was damaged, but not completely broken.

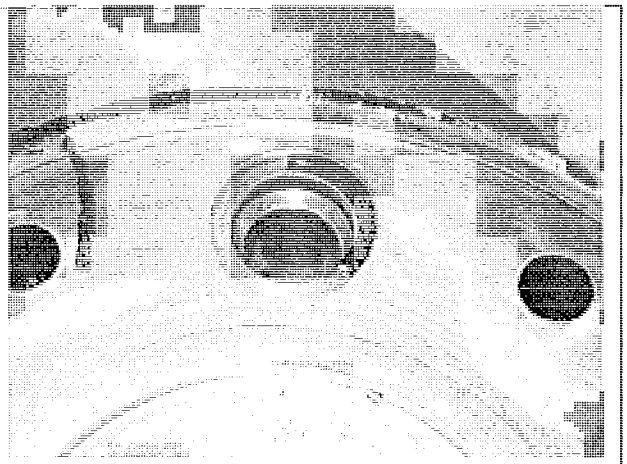
Damaged o-rings

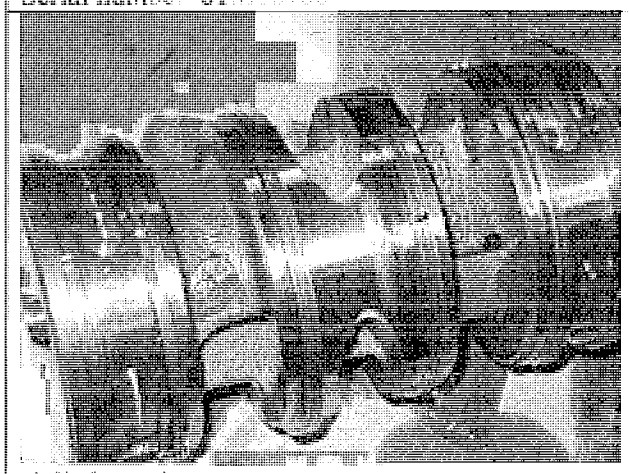
Galled spool.

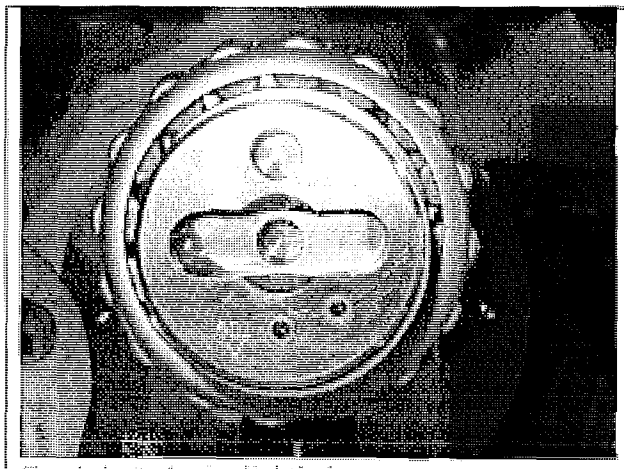
Crankshaft slot is slightly bent.

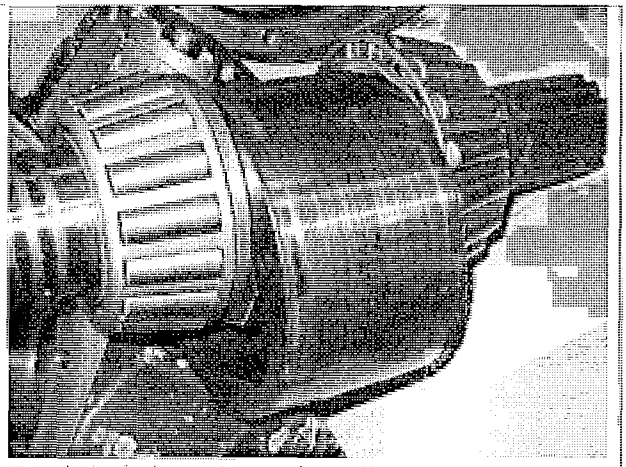
Crankshaft throw is good condition.

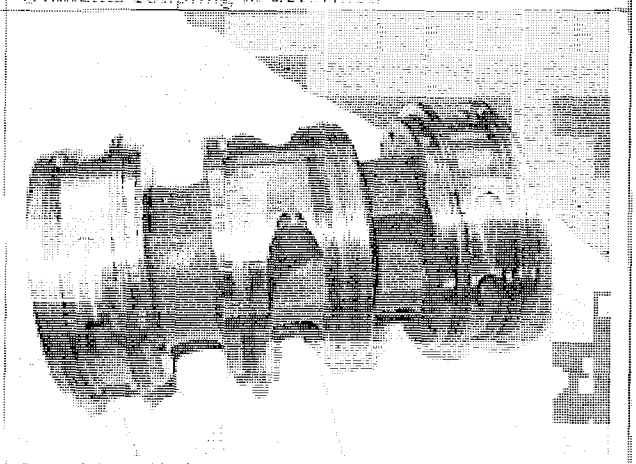
Spool is galled and discolored by heat

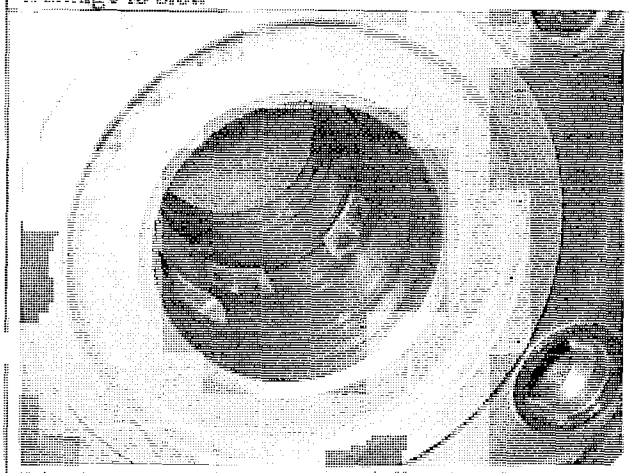
Distributor housing galled and discolored.

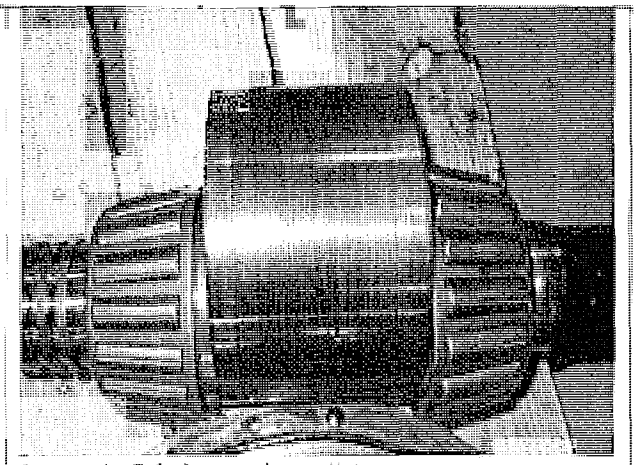
Crankshaft is in good condition

Summary:
The damage, in varying degrees, is the same from motor to motor. It appears that the first motor to fail, serial number 00124813, must have had the distributor valve seize quickly as the coupling sheared and there was no real impact to the end of the crankshaft. The others were either lightly seized or had operated with some amount of seizure over time. This type of failure is usually the result of the motor operating in an over speed condition, >1000 rpm. Over speed could lead to cavitation or perhaps a circuit problem could result in low charge pressure and cavitation. In either case, if the spool were to turn in the valve housing with little or no lubrication, the result would be heat and possible seizure of the spool in the housing. The inertial load or the torque generated by the other motors would shear the coupling of the first motor, the fall may have cavitated the other motors.

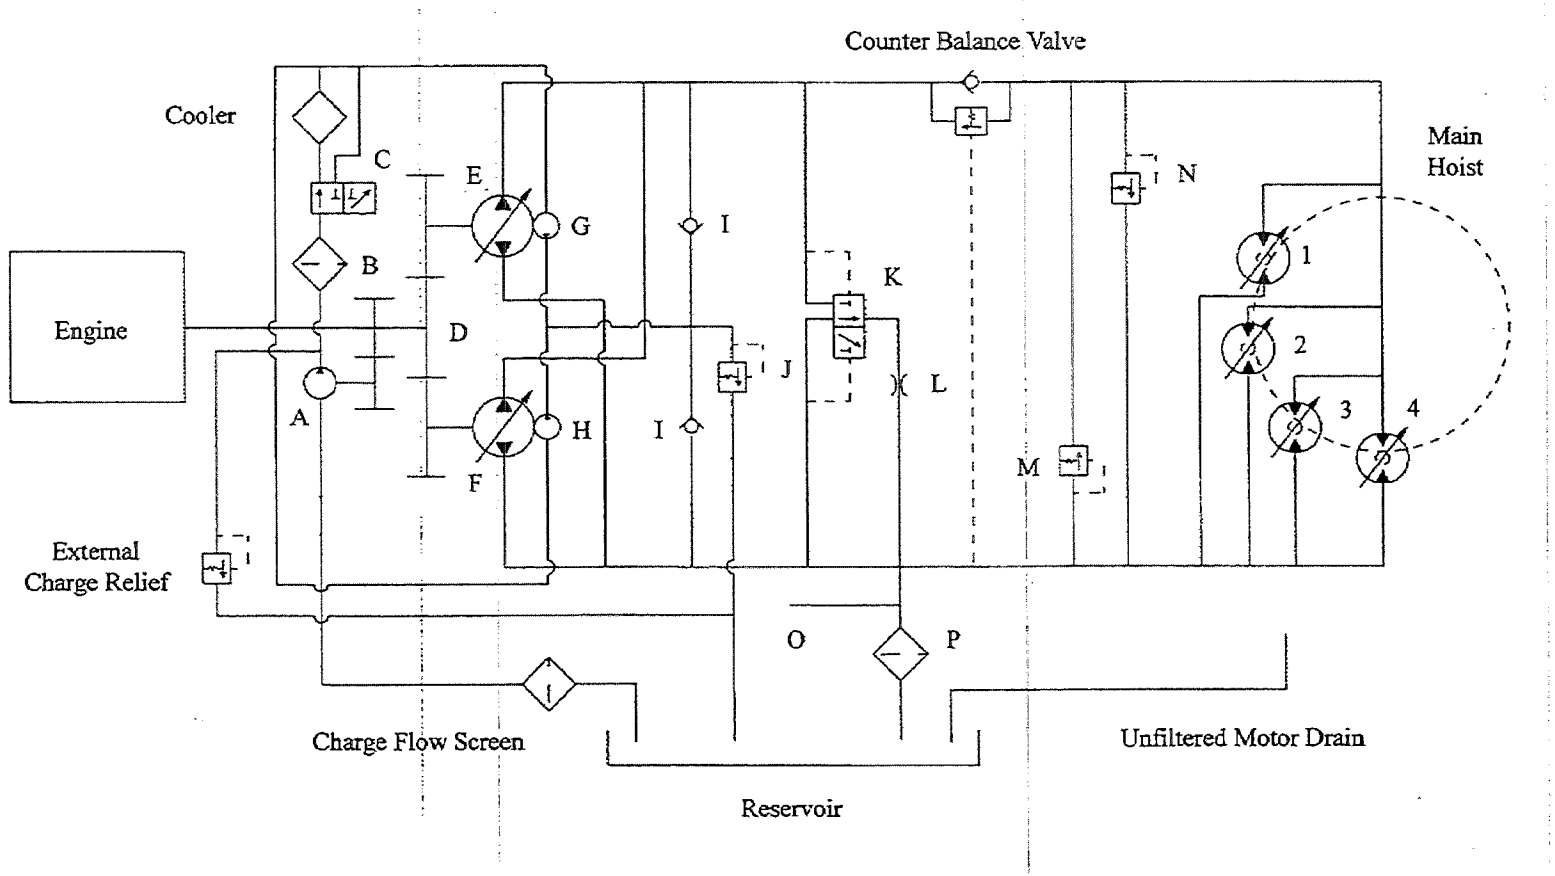
Figure 1. Schematic of the main hoist hydraulic circuit

4. The case flow for the motors is obviously an important concern for this design since the return flow from the motor case remains unfiltered to avoid back pressure (operator's manual, p. 7-5). Furthermore, each motor is equipped with its own visual flow meter for inspection during the life of the machine.

1. The hydraulic motor labeled 4 in Figure 1 and 2 was disassembled first. There was an obvious interest in disassembling this motor first because it the case had a large hole in it, from which a connecting rod had been thrown out of the machine during failure, along with another large piece of metal that appeared to belong to one of the hydrostatic bearings. The following things were observed during the disassembly process:
   a. Two jars of oil were extracted from the motor case before the motor was removed from the winch pack. These have yet to be analyzed.
   b. Seals and o-rings for the motor appeared to be in good shape, with no unusual signs of extrusion or other deformation.
   c. There were many metal parts scattered throughout the motor case ranging from long strips of material extending up to 30 cm in length to observable metal shavings less than

one millimeter in size. Many small pieces of metal were found of the approximate size of a penny. Most of these metal parts appear to have come from the mangled hydrostatic thrust bearings which had been destroyed due to an apparent over-speed phenomenon.

d. The machine was designed with 5 pistons. The piston labeled number 1 was the only piston to have lost its connecting rod. In fact, the connecting rod was found on the job site, indicating that this was the object that had most likely created the hole in the motor case. By disconnecting the connecting rod from the piston, a 5 mm lubrication passage from the pressurized side of the piston was opened up to the motor case. With a 5 mm hole like this, it is unlikely that the system could have held system pressure.

b. This motor exhibited similar failure symptoms of Motor 4; however, the connecting rods were all nominally in place, indicating that the 5 mm lubrication passages from the pressurized side of the pistons were not opened and pressure could have been held by these pistons.

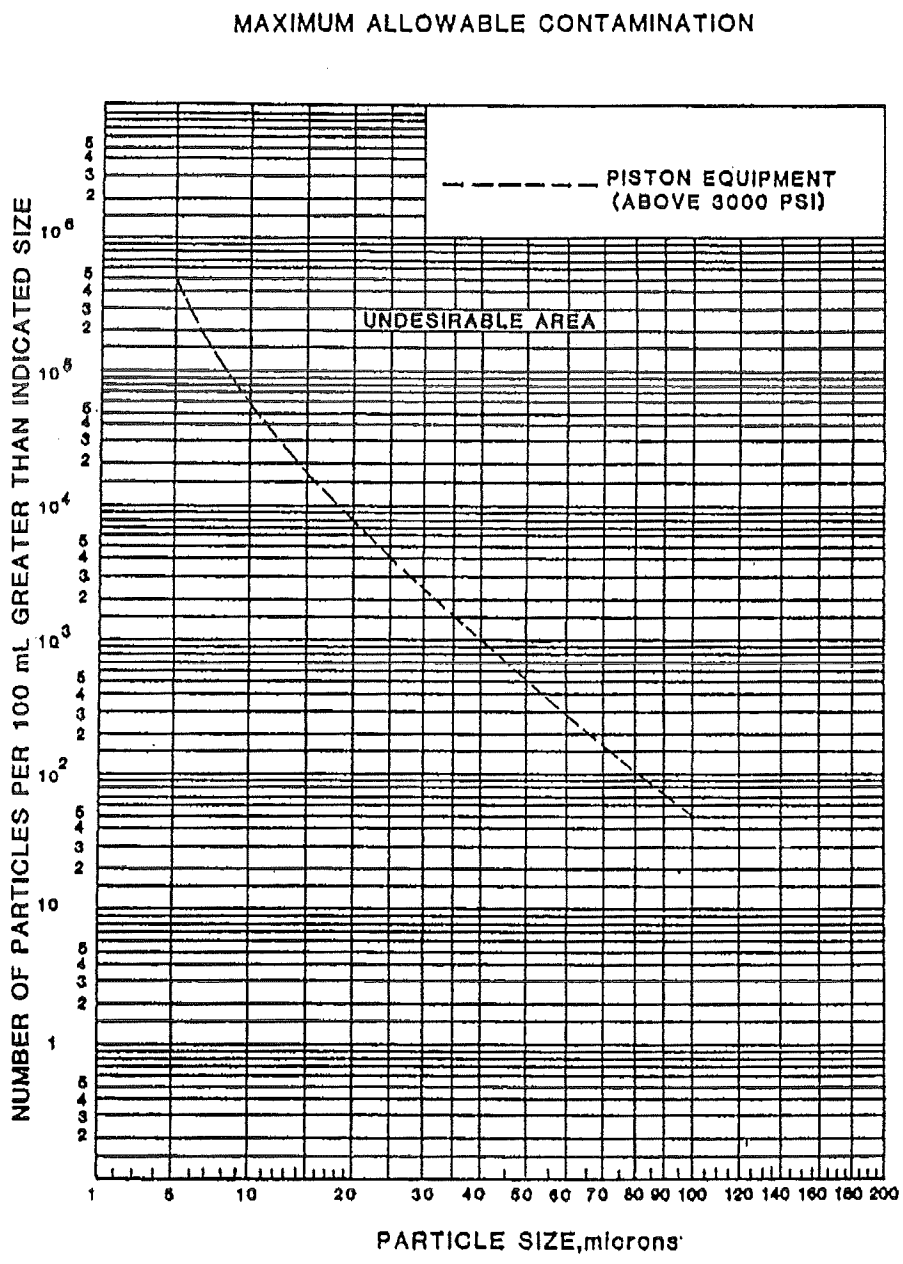
Fig. 5-35
Maximum Allowable Contamination Level

Under the heading, "Allowable Contamination Level" on page 5-44 of the manufacturer operator's and maintenance manual states, "Figure 5-35 shows the maximum allowable contamination level for this model crane. Any count above that level means that the hydraulic oil must be replaced..." (Refer to **Attachment E** for Figure 5-35.)

1. The <u>water content of 0.548% in this fluid is 5 to 10 times too high</u>. Current practice is to keep the water content less than 0.1% but some recommend keeping the content less than 0.05% [6]. Without any question, fluid that has a water content of 0.2% should be discarded and replaced and water content is the most important factor in fluid property degradation.
2. According to the crane Operator's Manual [7], the contamination level for the fluid is far above recommended values (off the charts) that are given in Fig 5-35, on page 5-45.
3. According to ISO 4406:1999 [8], and the Staffa motor literature [2], the class of particles per milliliter in the fluid greater than 5 microns in size should be less than 18, and the class of

Figure 5-35 shows the maximum allowable contamination level for this model crane. Any count above that level means that the hydraulic oil must be replaced as described earlier in this section of the manual, or filtered using a filter buggy.

The oil must be filtered until the contaminate level is below that shown in Fig. 5-35.
