List of specific record(s):
I am requesting copies of any and all reports prepared by Haag Engineering of Sugar Land TX, the expert retained to investigate the February 16, 2012 Crane Incident at World Trade Center

World Trade Center 4500063211
4 World Trade Center
New York, NY
Client File: 4500063211
Haag File: 0212001176-250

The Port Authority of NY and NJ
Port Authority Safety Board
225 Park Avenue South 15th Floor
New York, NY 10003

December 21, 2012

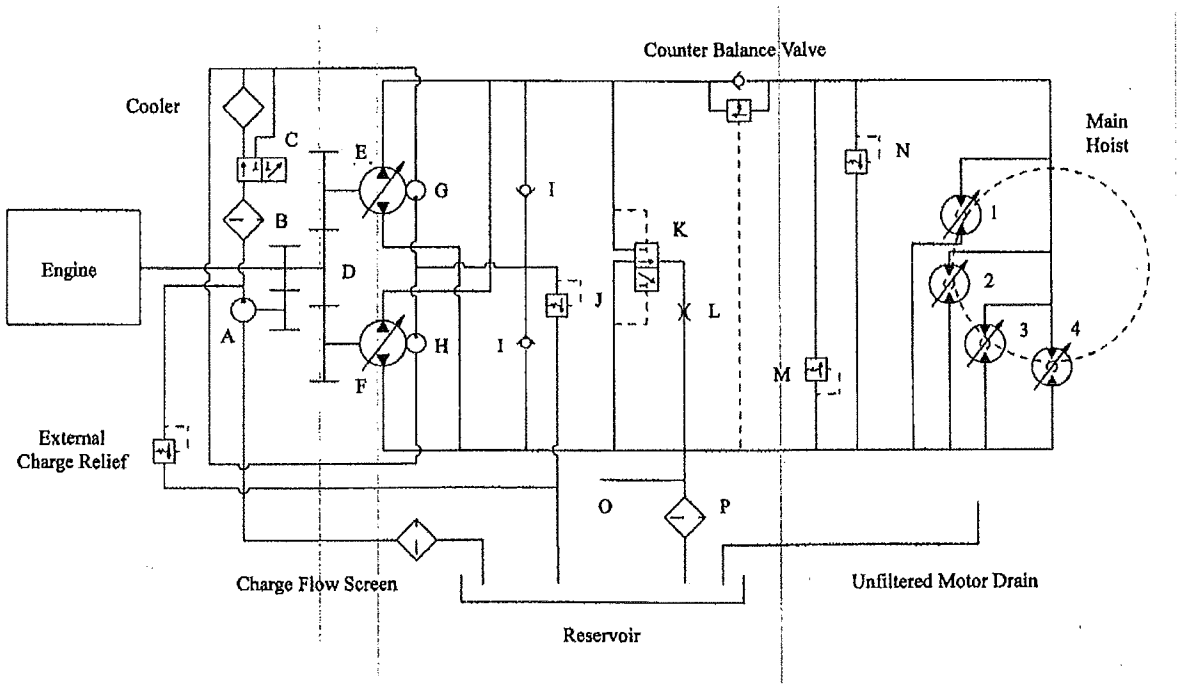
undergoes the seizing of a distributor; thus, effectively disabling the motor from the lift circuit and reducing the load capacity of the crane. This hypothesis is supported by the fact that the coupling key between the motor shaft and the distributor was broken on all four motors of the crane that failed, and that a similar accident in 2011 discovered a broken coupling key in one of the motors used in that crane. Furthermore, a mathematical model of the crane lifting circuit has been built using Matlab / Simulink ® and this model reveals that a seized distributor in one motor would have been sufficient to drop the payload as was experienced during the actual accident. Other failure hypotheses have been tested in the numerical model as well, but none of these have shown probable cause for the accident. Therefore, the hypothesis of a seized distributor being the initial cause of the accident remains in the forefront of this investigation.

Figure 1. Crane hoist system, showing four motors for lifting the payload

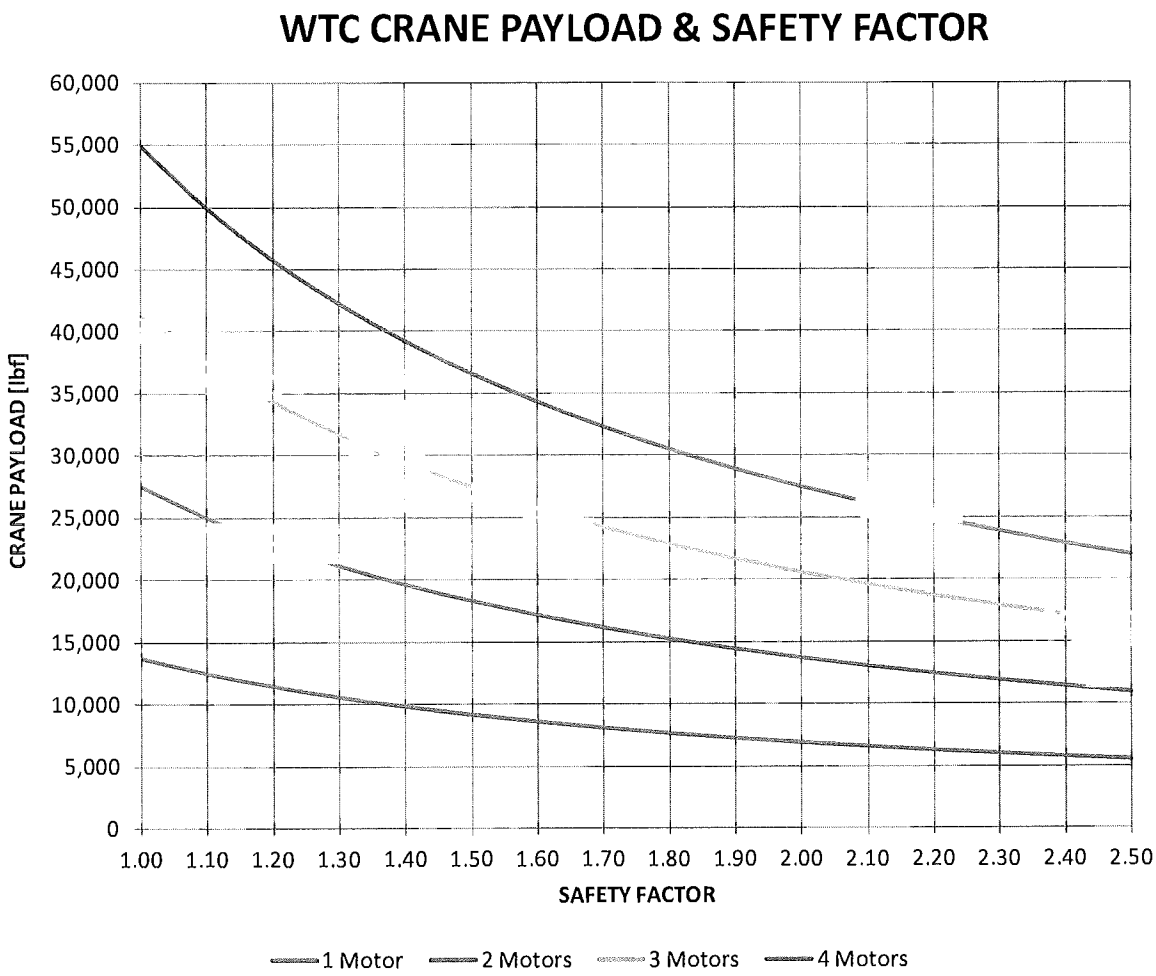
Using these parameters, the graph in Figure 2 was produced from Equation (3) to describe the recommended payload for the crane versus a desired safety factor for the lift. Note: a safety factor of 1.00 provides no margin for error. Usually, a safety factor between 1.00 and 2.00 is used for a safe design practice. In Figure 2, the graph is plotted for the number of motors that are active. The purple line represents a working condition where all four motors are active, the green line represents a condition where only three motors are active, the red line represents a condition where only two motors are active, etc. As Figure 2 shows, the recommended load carrying capacity for the crane decreases as the desired safety factor increases for all working conditions.

Figure 2. Payload capacity versus factor of safety and number of operating motors

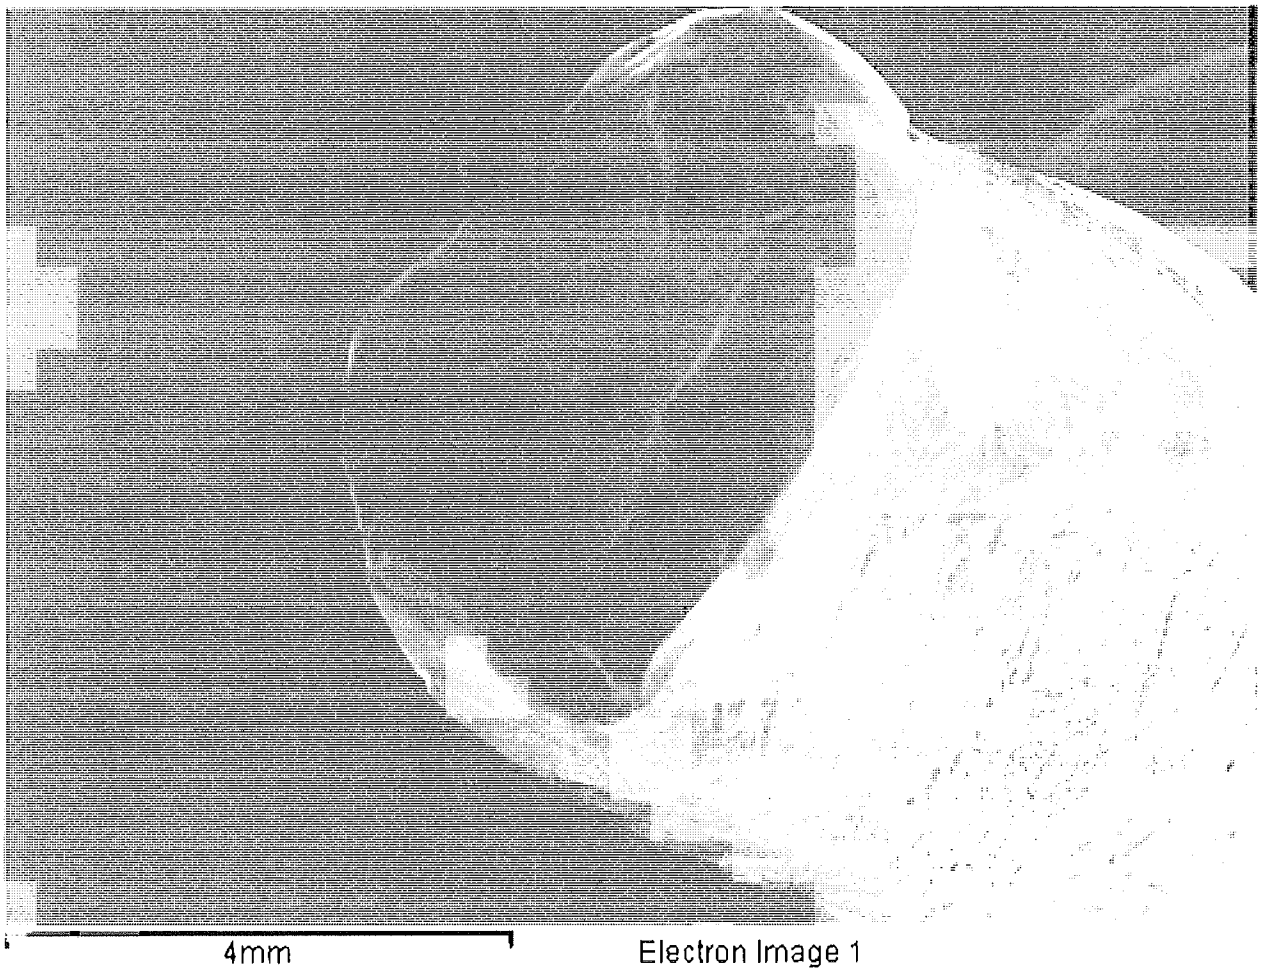
Scanning Electron Microscopy (SEM) reveals severe crushing, cutting, and shearing of the outer wires at the location of the break (Photographs #25, #26, #27 & #28).

PHOTOGRAPH #25
SEM PHOTO OF DAMAGE AT BROKEN WIRE END

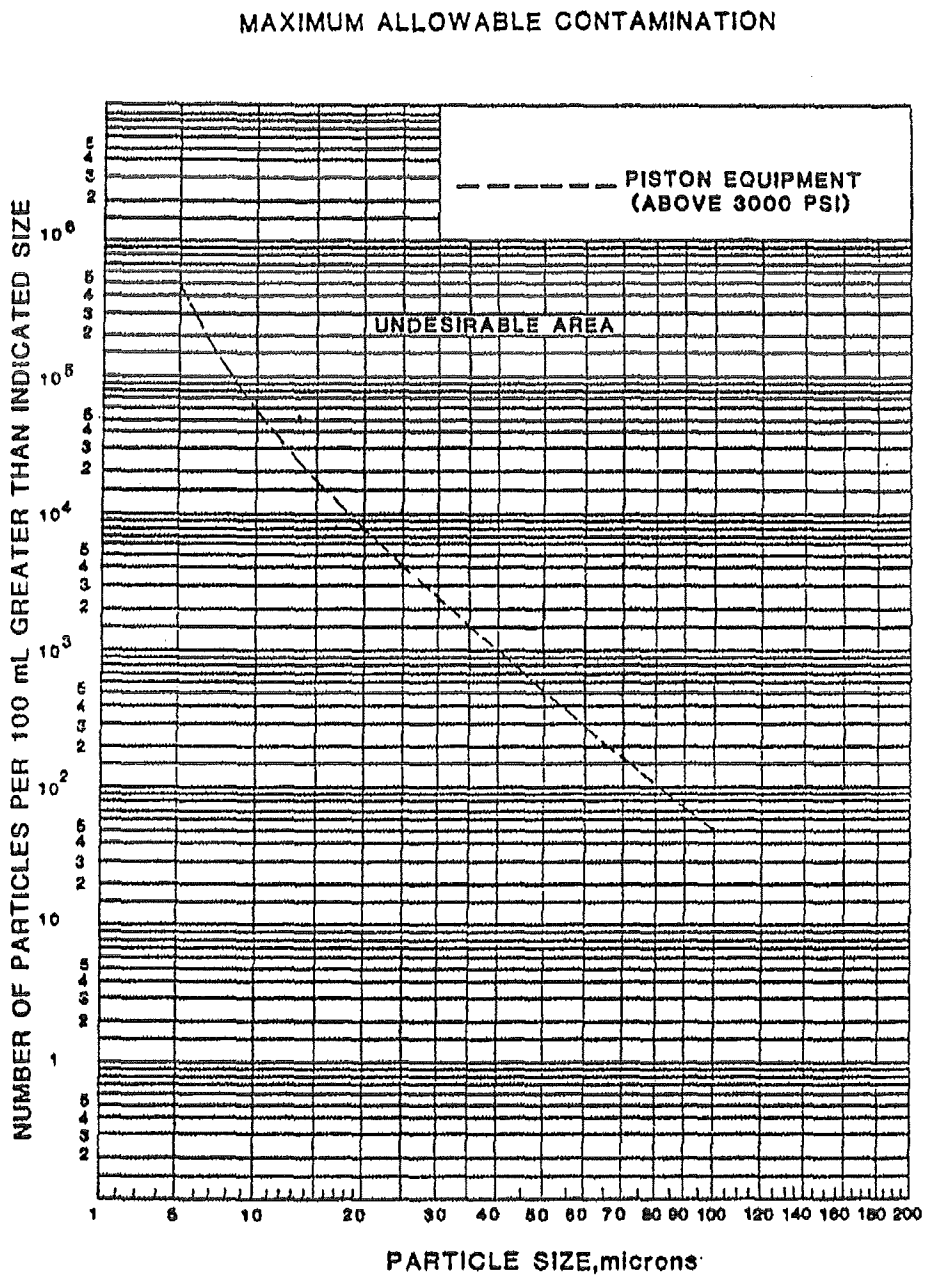
Fig. 5-35
Maximum Allowable Contamination Level

Figure 5-35 shows the maximum allowable contamination level for this model crane. Any count above that level means that the hydraulic oil must be replaced as described earlier in this section of the manual, or filtered using a filter buggy.

The oil must be filtered until the contaminate level is below that shown in Fig. 5-35.

(8) Open butterfly valve and prime pumps and motors as necessary, as described earlier in this section of the manual.
(9) Obtain an oil sample as described earlier in this section of the manual.
(10) If the contamination level is below that shown in Fig. 5-35, put the machine back to work. After 50 hours of operation, change all oil filters.
