# **Port Authority Facility Condition Survey Program**

**Port Authority Bus Terminal  
2014 Inspection Report of  
Bus and Car Parking Level Slabs**

**November 2014**

Subject: CONDITION SURVEY OF PORT AUTHORITY BUS TERMINAL, BUS AND CAR PARKING LEVEL SLABS P.O. 4900010549

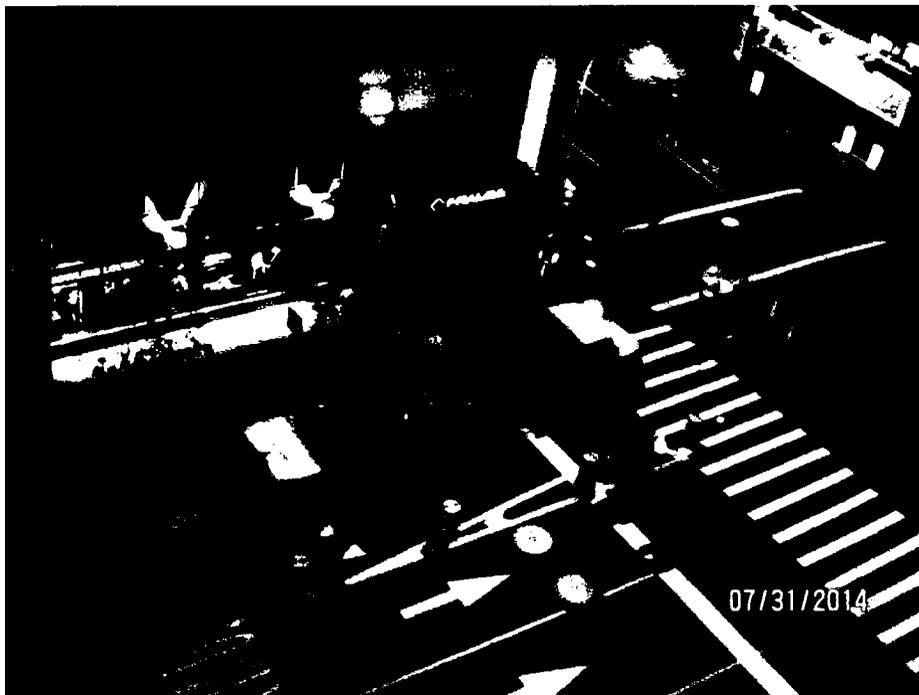
**Photo No. A2**

**Location:**  
Upper Bus Level,  
South Wing,  
Entrance Ramp to  
Upper Bus Level  
(looking southwest,  
shown on Dwg. 16,  
pg. 45)

**Description:**  
60 ft. man-lift used  
to access the West  
Truss

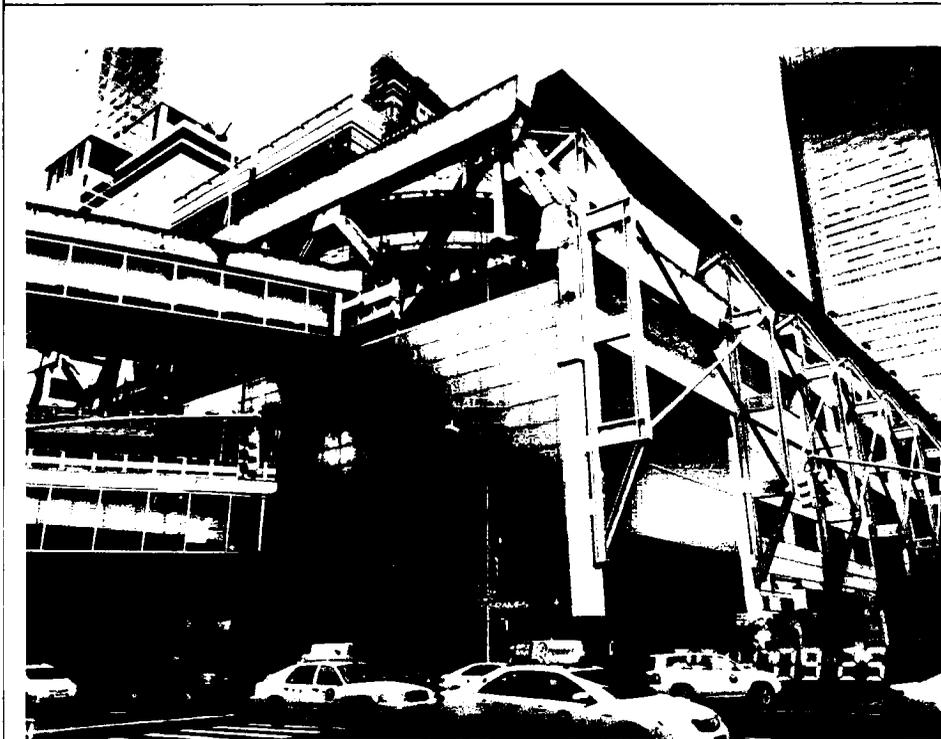
**Location:**  
North and East  
Elevation (looking  
Southwest, shown  
on Location Plan,  
pg. xi)

**Description:**  
General View

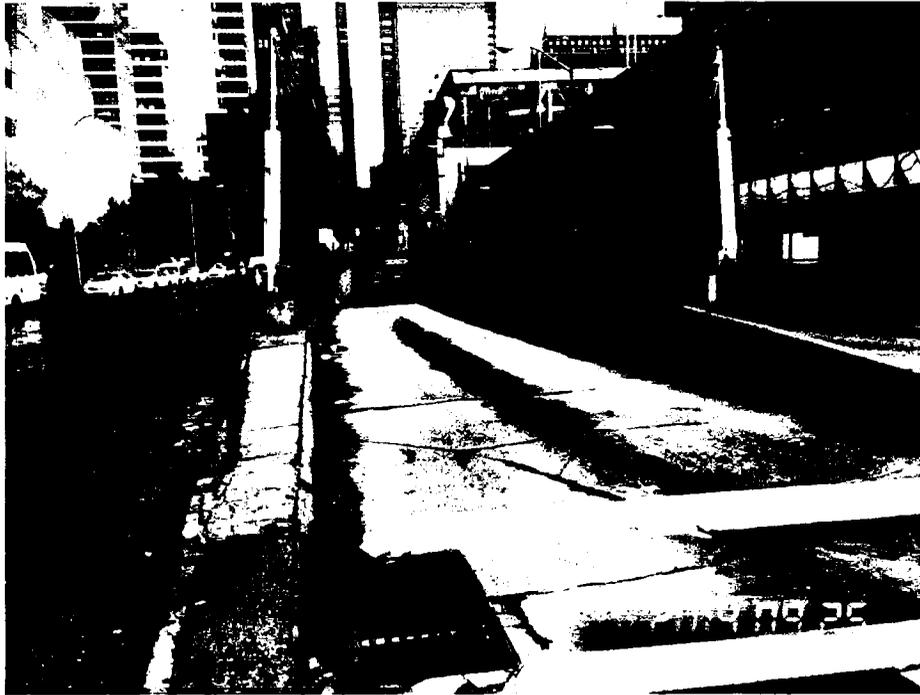
**Photo No. 2**

**Location:**  
South and West  
Elevation (looking  
Northeast, shown  
on Location Plan,  
pg. xi)

**Description:**  
General View
