**Engineering
Quality Assurance Division
B02-925.078**

Port Authority Facility Condition Survey Program

September 2011

Reference: P. A. Agreement No. 405-11-022
Professional Services for the Condition Survey of
Holland Tunnel Air Ducts and Drum Rings

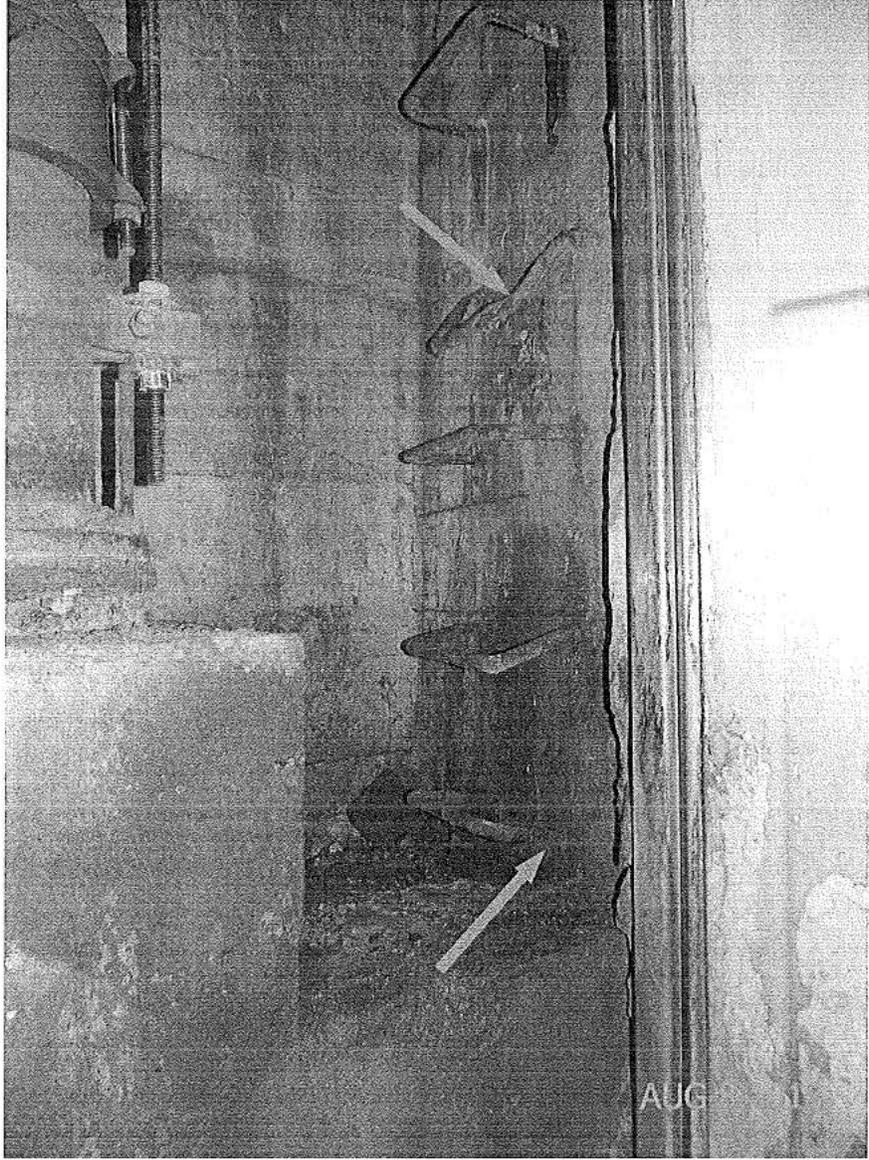
There was 1 priority repair at one location recommended during the previous inspection which remains outstanding. The priority repair consists of a construction joint (between the outside skin plate of the caisson and the concrete roof of the offset duct) that has separated along the entire width of the duct with water seeping. No new priority repairs were recommended during the current inspection. The location and description of the priority repair is furnished in Table C1 and the location is shown on Figure C1.

There were 5 routine repairs at 43 locations noted during the current inspection. Routine repair recommendations are presented in Table C2 and their locations are shown on Figure C1.

There was 1 finding with no recommendation at 4 locations. The finding with no recommendation is presented in Table C3 and the locations are shown on Figure C1.

Finding #	Tunnel Type	Area	Station	Description	Figure #
1	Steel Bent	NB1	1+00 (2 locs.)	Medium spall and adjacent hollow concrete. (4 locs.)	C1
		NB2	1+00		
		SB1	2+00

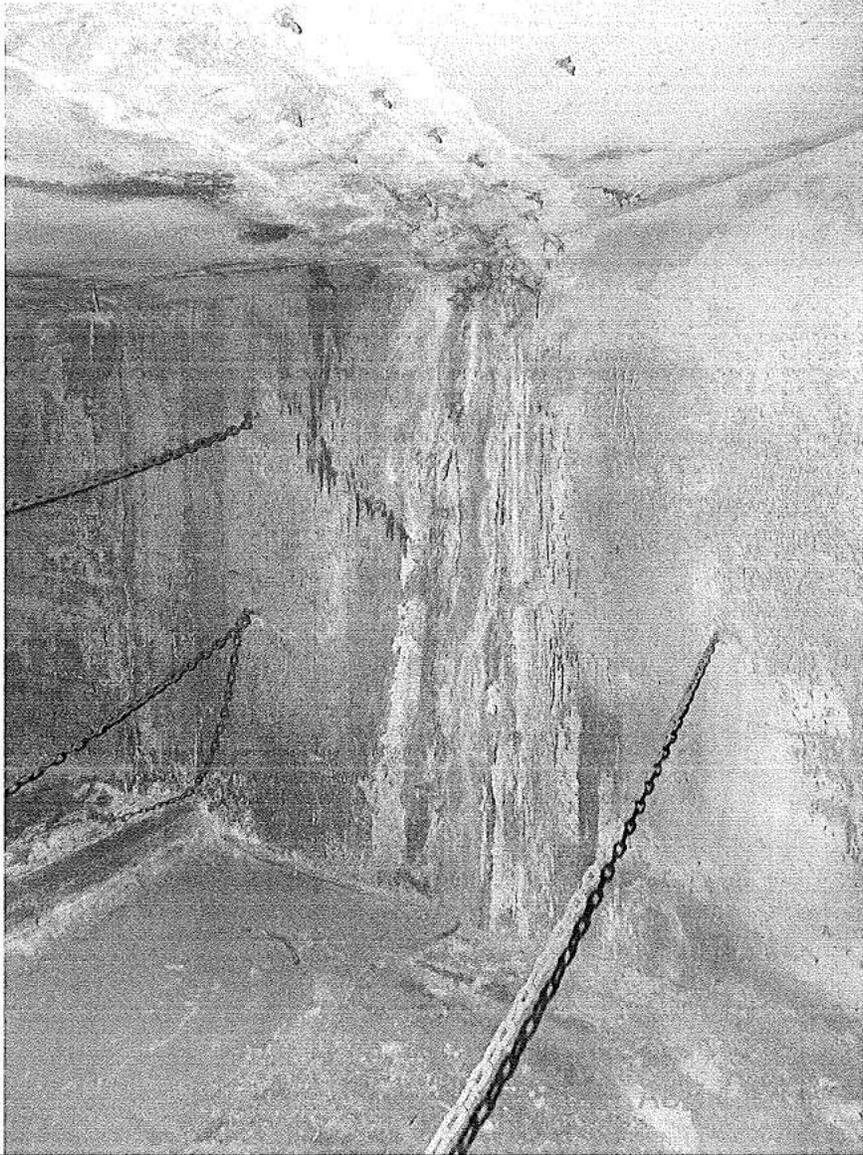
Routine Repair #	Location	Station	Description	Repair Recommendation	Figure #
R1	Pump Room	--	Medium to wide crack in concrete wall/column encasement/deck slab. (18 locs.)	Repair cracks.	E1 & E2
R2	Pump Room	--	Medium to large spall in concrete wall/underside of deck slab. (5 locs.)	Repair spalls.	E1 & E2
R3	Pump Room/ Sump Chamber	--	Large spall in concrete deck slab/ beam encasement with adjacent hollow concrete. (6 locs.)	Remove hollow concrete and repair spalls.	E1
R4	Pump Room	--	Seeps in wall. (2 locs.)	Clean and seal leaks.	E2
R5	Pump Room	--	Severe corrosion of conduit brackets. (1 loc.)	Repair conduit brackets.	E2
R6	Sump Chamber	--	Fine crack seeping at underside of concrete deck slab. (6 locs.)	Clean, seal leaks and repair cracks.	E2
R7	Sump Chamber	--	Moderate to severe corrosion of manhole frame. (1 loc.)	Clean and repaint manhole frame.	E2
